# ENERGY RELATED PERFORMANCE TESTING OF MINNESOTA LOG HOMES

JUNE 1990

## MINNESOTA DEPARTMENT OF PUBLIC SERVICE ENERGY DIVISION

Prepared by  
Stephen R. Klossner  
Advanced Certified Thermography  
Lakeland Minnesota

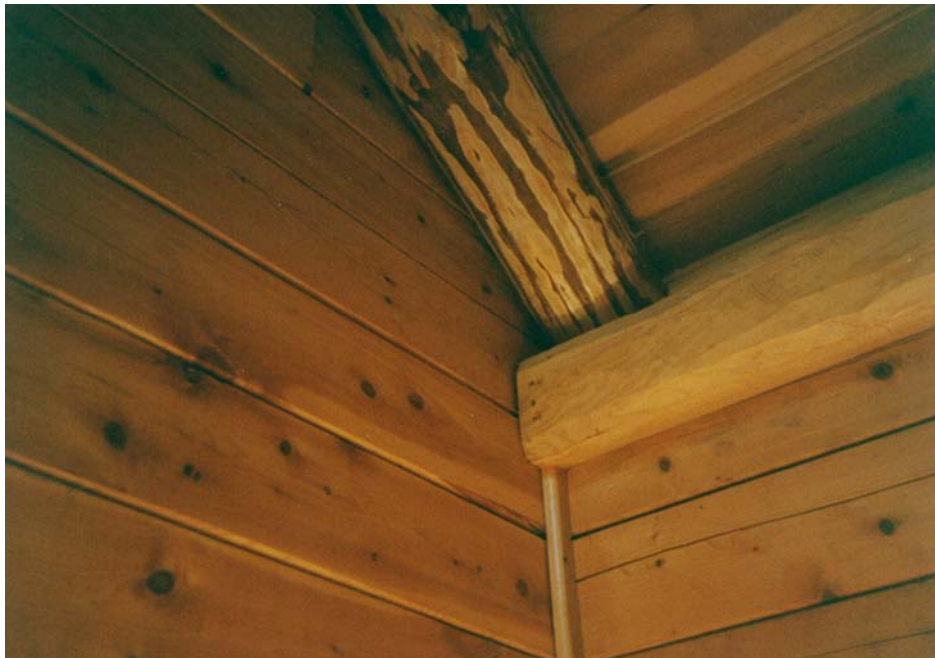
PHOTOGRAPH # 1

Photograph of area shown in thermogram.

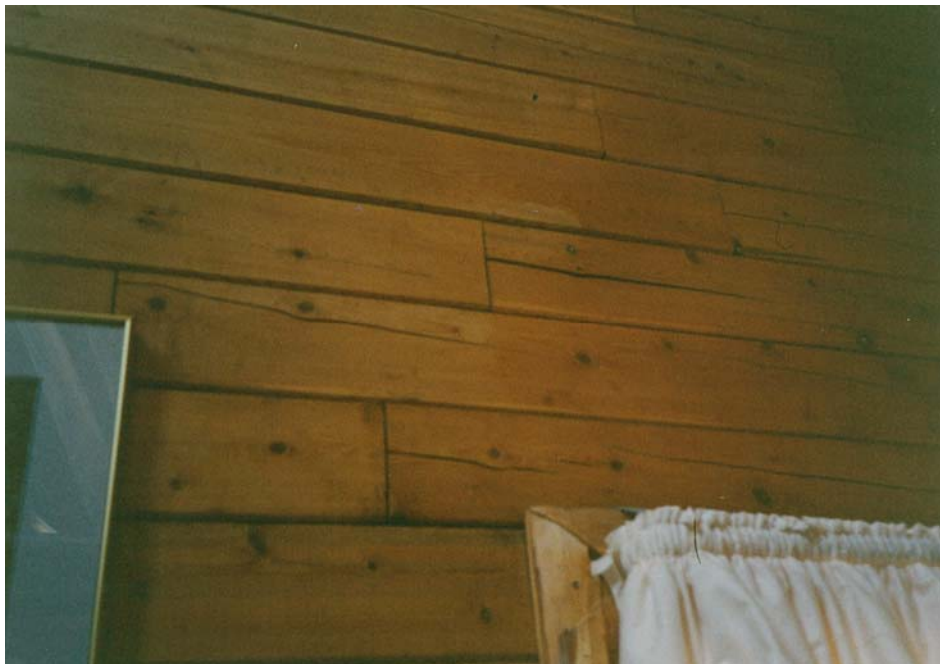
#### PHOTOGRAPH # 1

Photograph of area shown in thermogram.

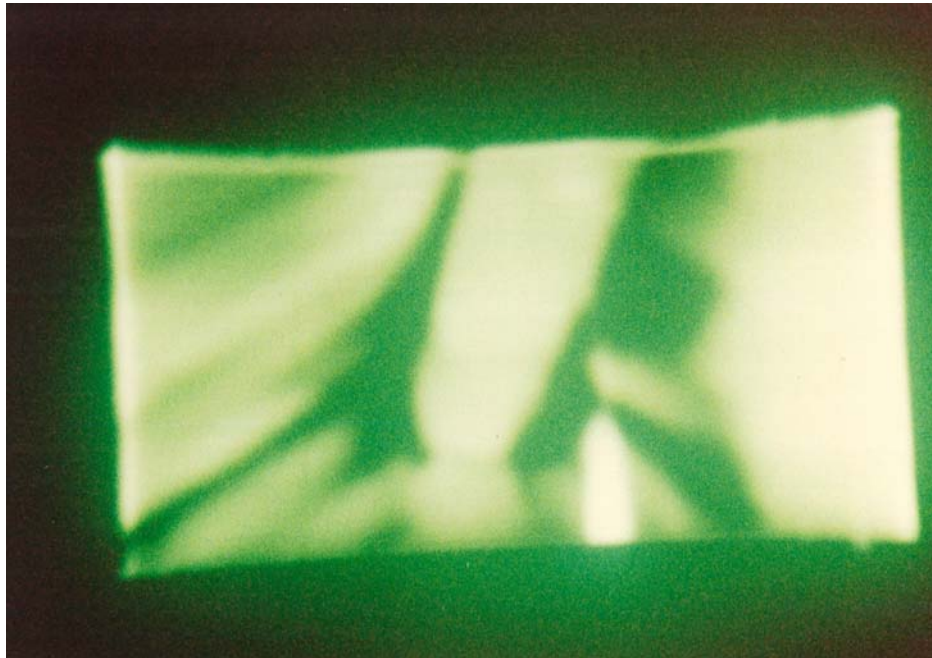
### THERMOGRAM #3

Dark is cold. Shows air leakage above the main ridge beam. This Type of leak was attributed to the cathedral ceiling.

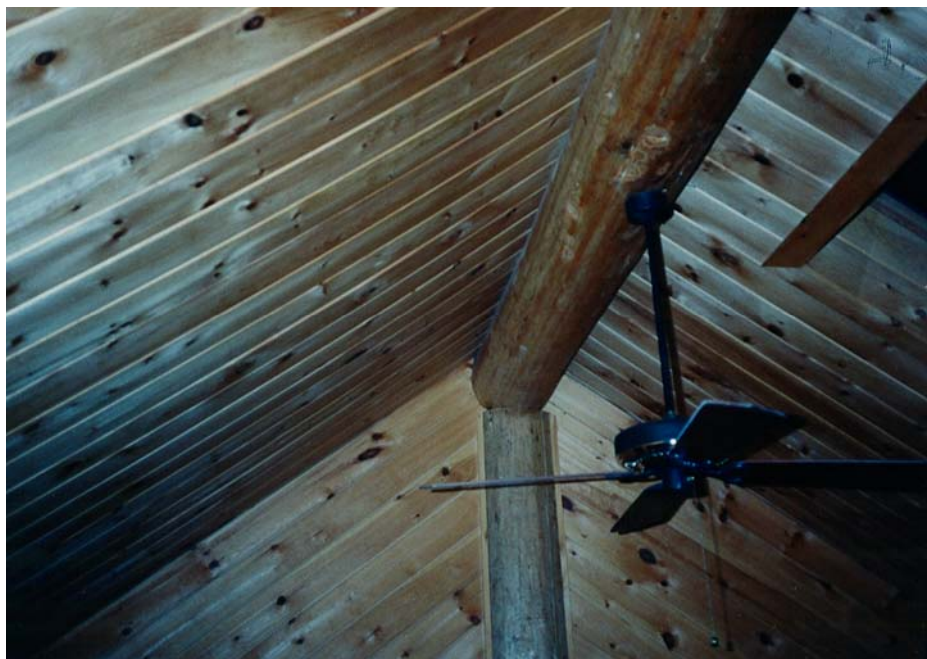
### Photograph # 3

Photograph of area shown in thermogram.

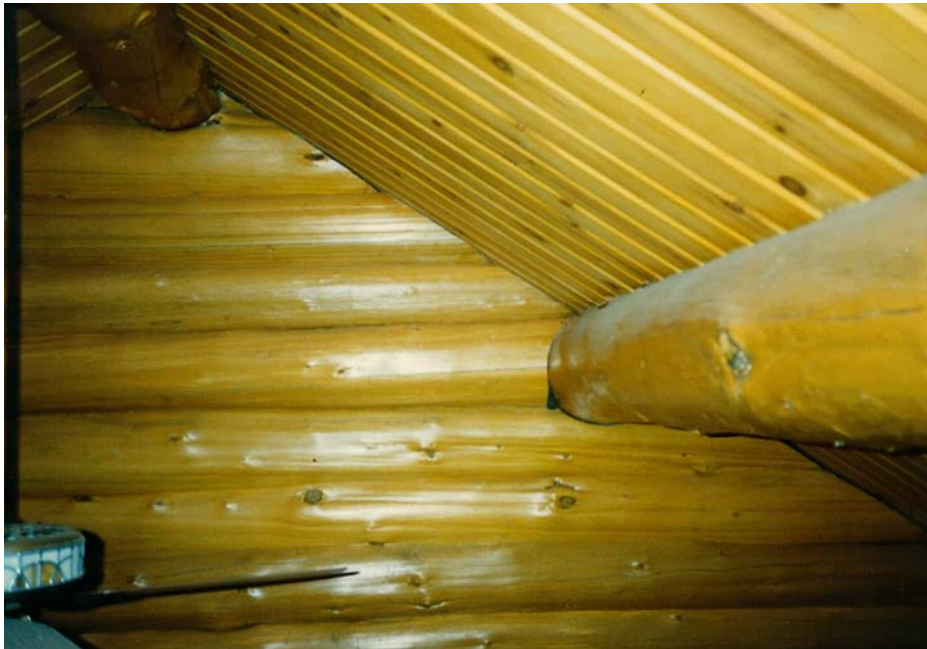
#### PHOTOGRAPH # 4

Photograph of area shown in thermogram.

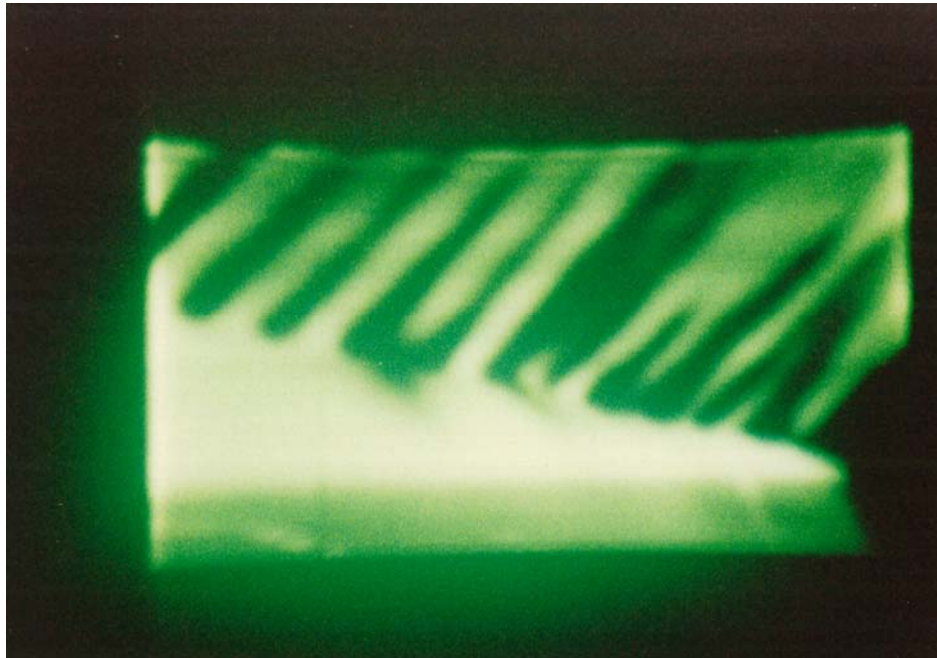
THERMOGRAM # 5

Far and away, the greatest leaks were found in the cathedral ceilings. This is partly related to the tongue and groove ceiling and partly related to the difficulty in maintaining a continuous vapor barrier (and air barrier) over the purlins. Also noted were three homes with no vapor barrier installed. In the majority of homes rigid insulation also acted as the vapor barrier. Although this system also leaked, it was not possible to inspect for the reason for this leakage because of inaccessibility. In two homes where access was available, one had the seams between the sheets sealed with duct tape, and the other had no sealing of the seams. Upon inspection, it was found that the duct tape was hanging away from the sheathing.

Dark is cold. Shows air leakage between the tongue and groove  
Cathedral ceiling.

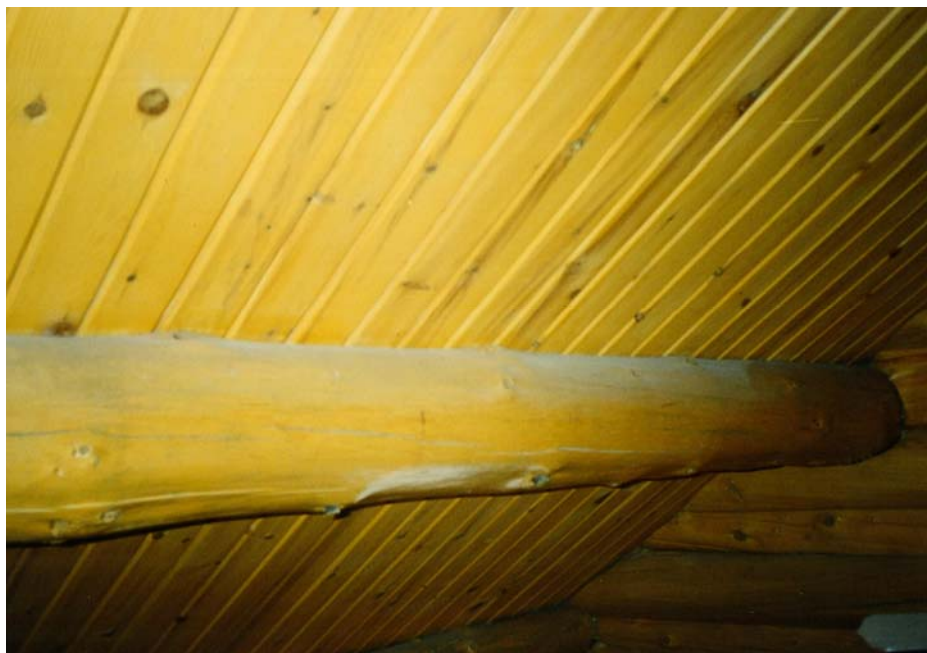
Photograph # 5

Photograph of area shown in thermogram.

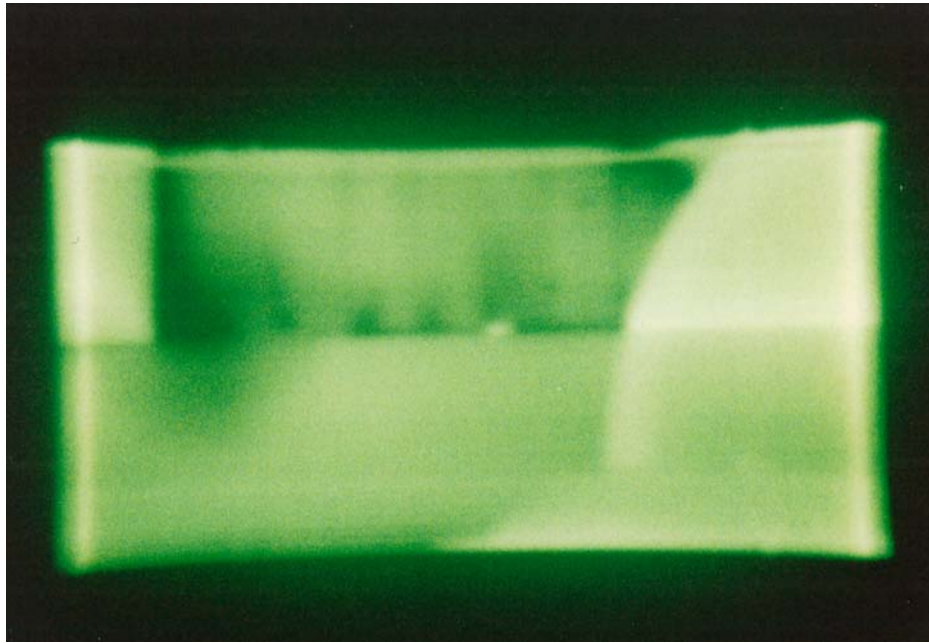
THERMOGRAM # 6

Dark is cold. Shows air leakage at the log top and window molding.

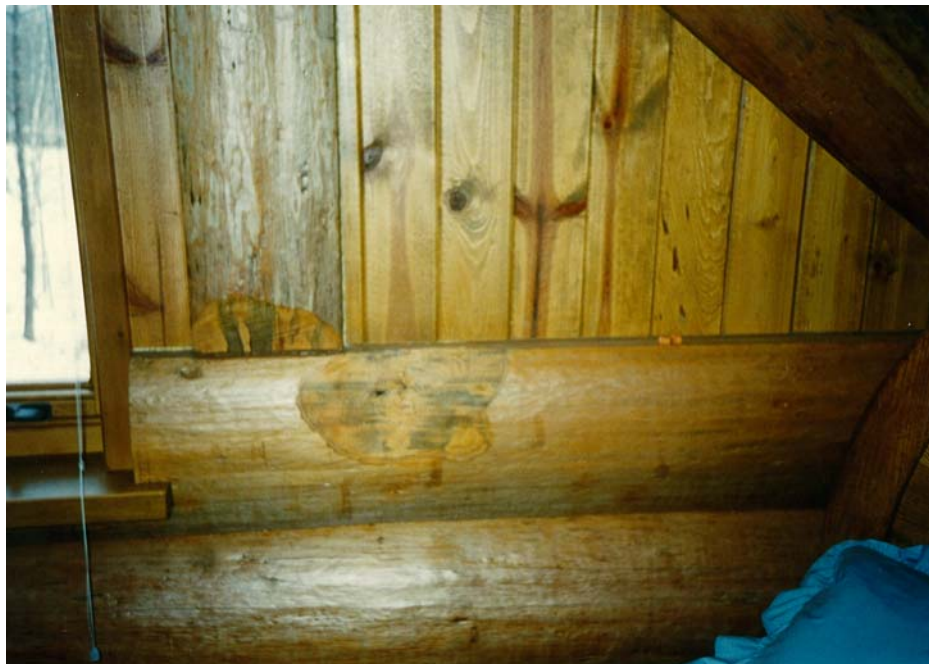
PHOTOGRAPH # 6

Photograph of area shown in thermogram.

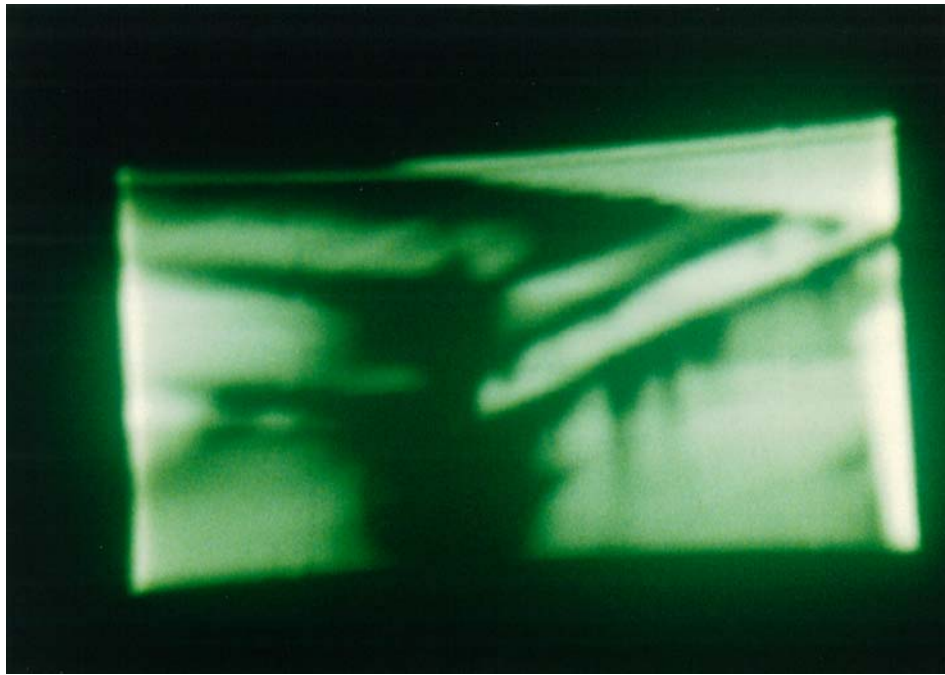
THERMOGRAM #7

Dark is cold. Shows air leakage at the log corners and dormer ceiling Interface.

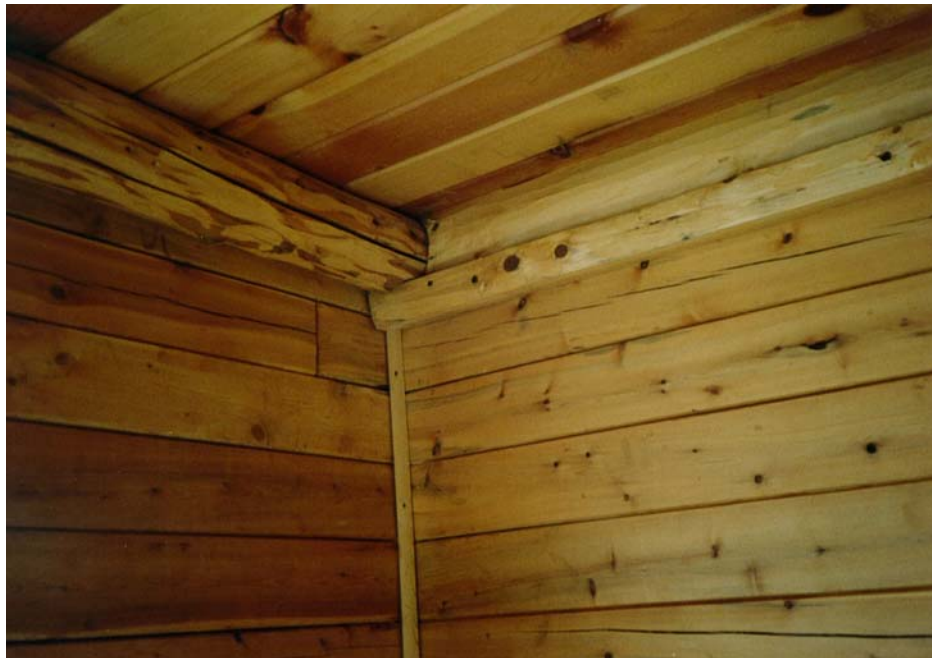
PHOTOGRAPH # 7

Photograph of area shown in thermogram.

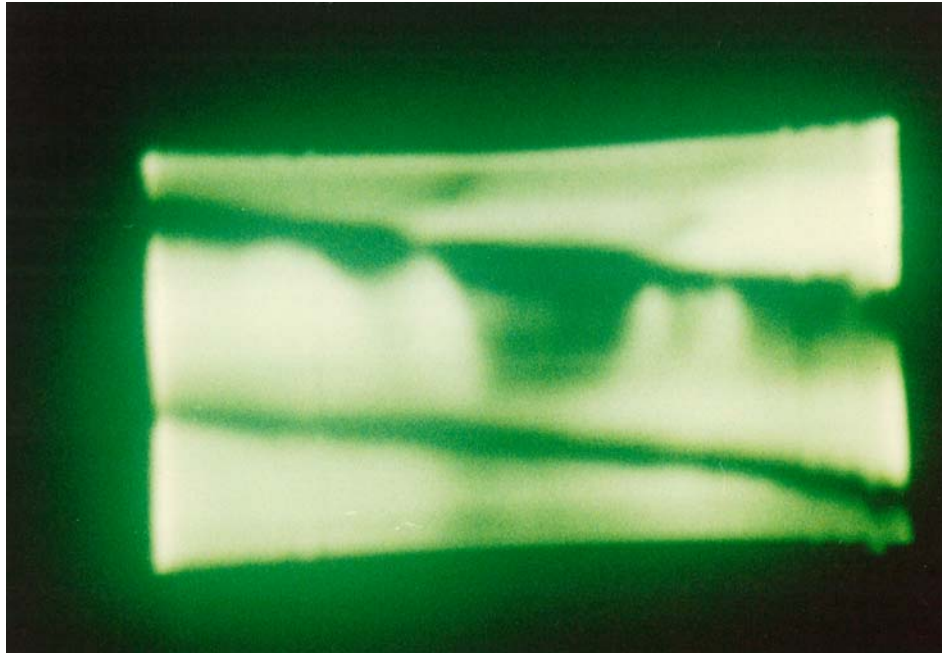
THERMOGRAM # 8

Dark is cold. Shows air leakage at log top and 2"x6" wall interface. Also can compare leaks at horizontal log and log top.

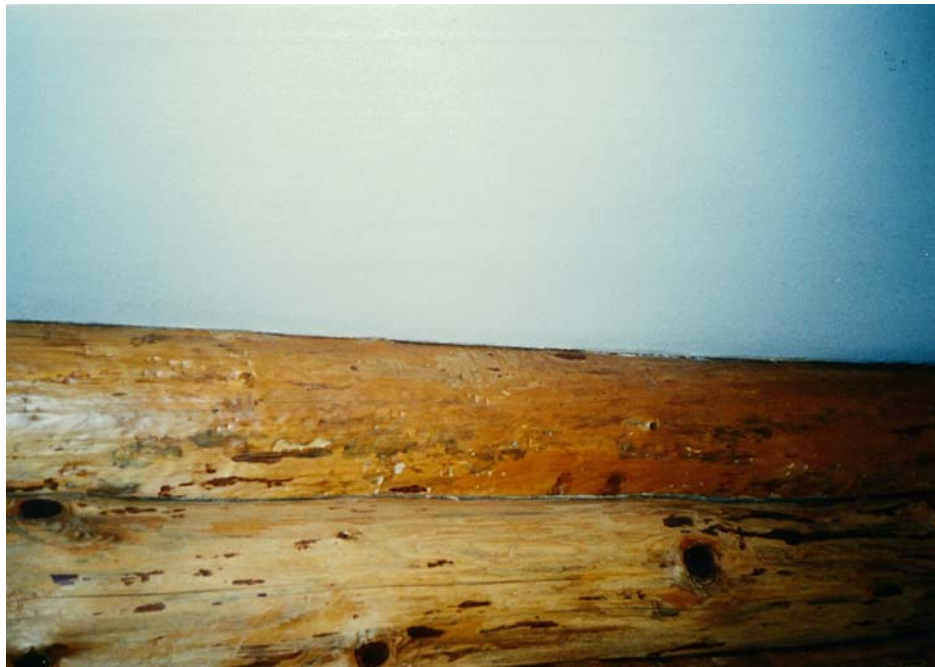
PHOTOGRAPH # 8

Photograph of area shown in thermogram.

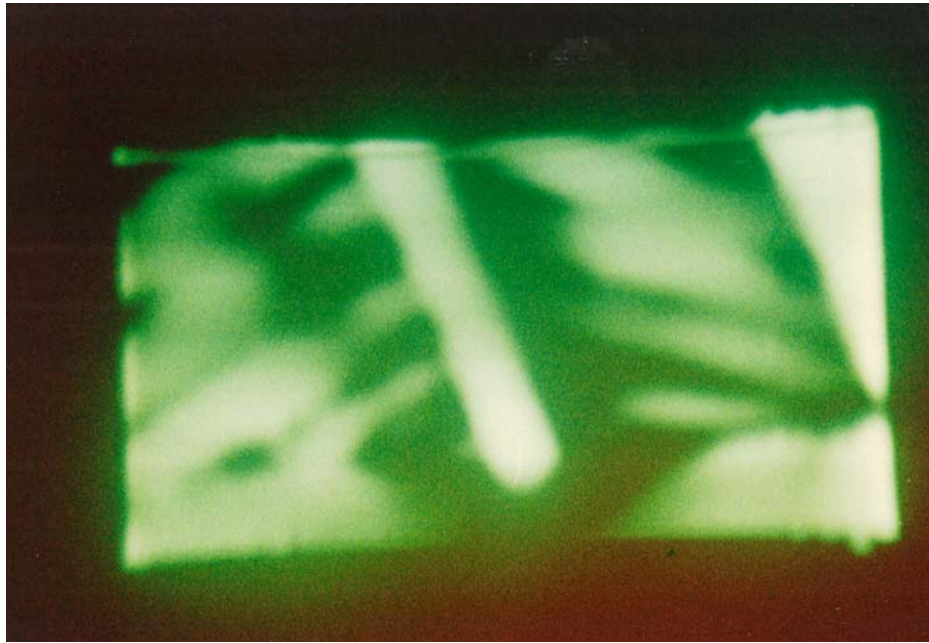
THERMOGRAM # 9

Dark is cold. Shows air leakage through the cathedral ceiling.

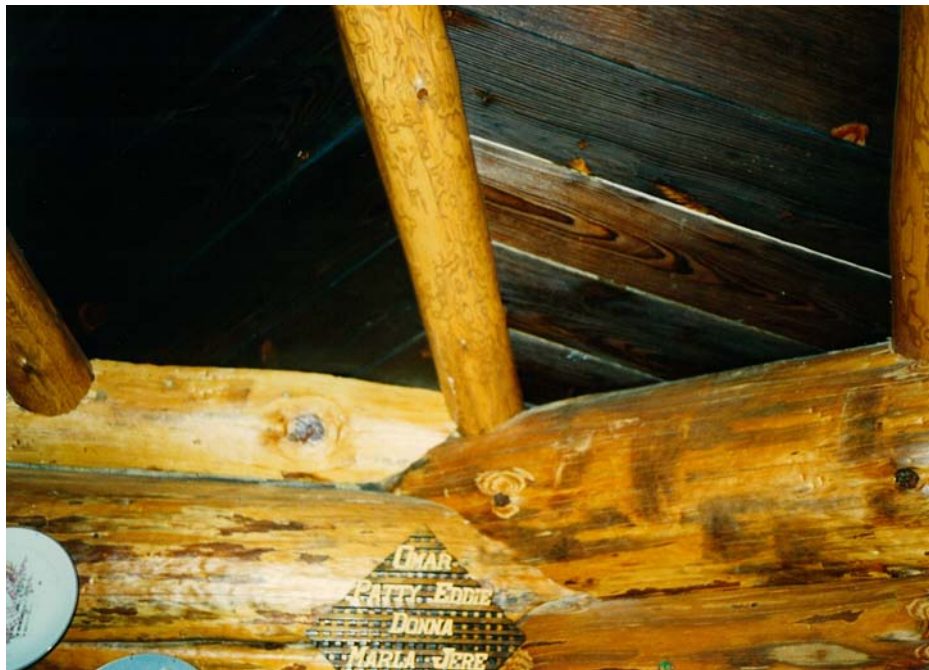
PHOTOGRAPH # 9

Photograph of area shown in thermogram.

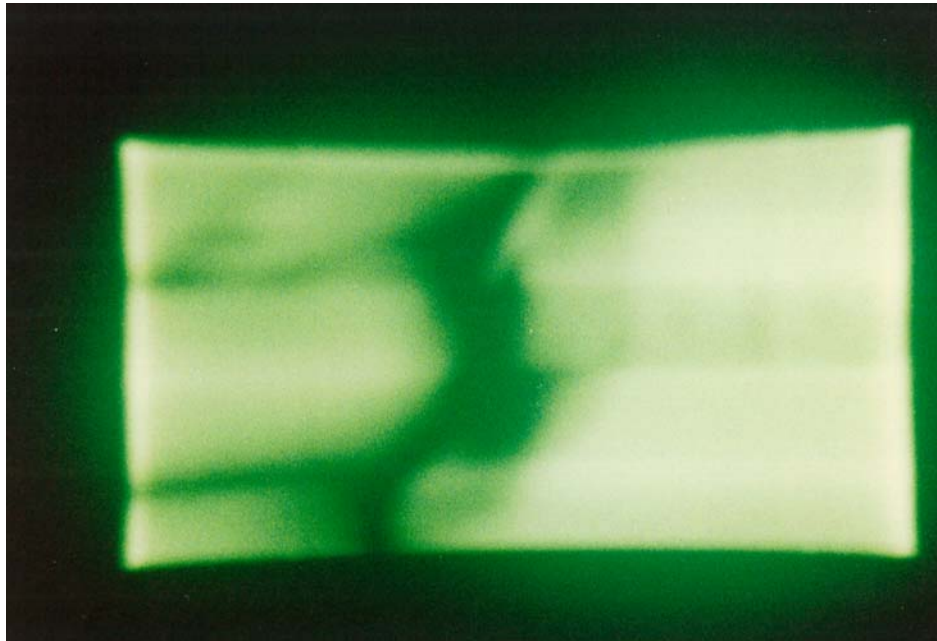
THERMOGRAM # 10

Dark is cold. Shows air leakage at corner, purlins and wall ceiling Interface.

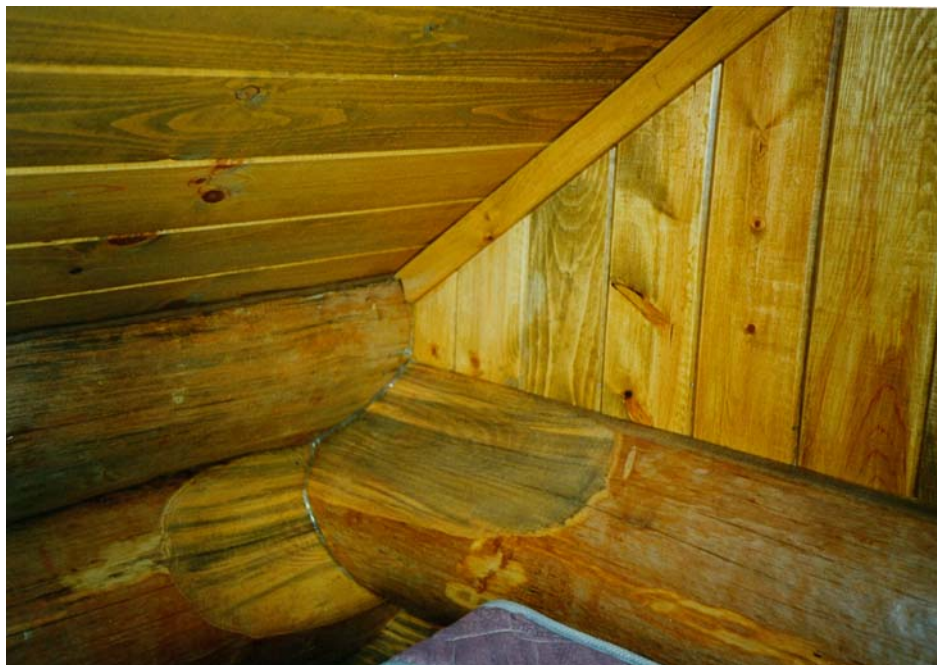
PHOTOGRAPH # 10

Photograph of area shown in thermogram.

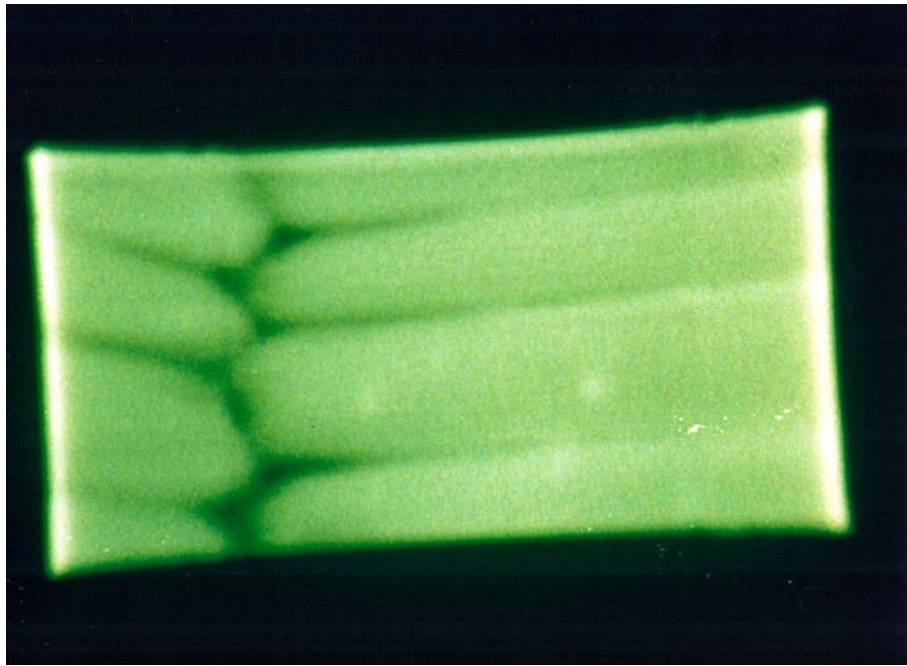
THERMOGRAM # 11

Dark is cold. Shows slight air leakage at corner and no leakage at horizontal log.

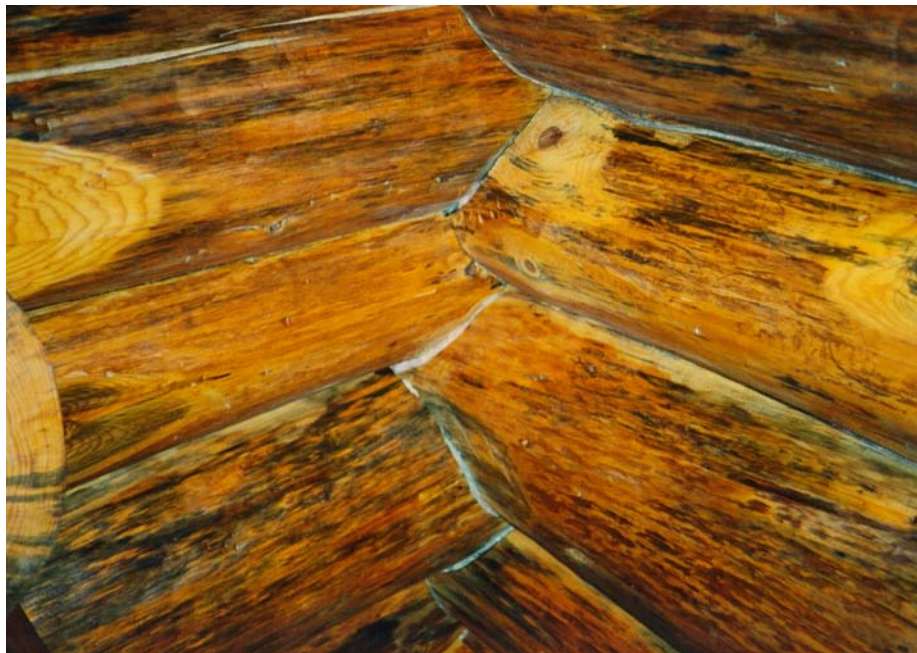
PHOTOGRAPH # 11

Photograph of area shown in thermogram above.
