Infrared Imaging and Log Construction Thermal Performance

*Eric G. Amhaus & Edward L. Fronapfel
Professional Investigative Engineers*

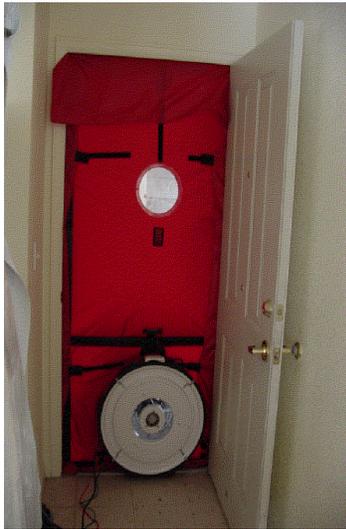
Figure 1. Blower door testing equipment/assembly installed for depressurization in main door opening.

Blower door or fan pressurization testing of a structure consists of negatively pressurizing (or depressurizing) a building, unit or structure to identify natural ventilation rates, air leakage paths or the tightness and energy efficiency of a property. The testing is accomplished with a specialized blower door assembly, and with today's technology, all documentation can be collected and stored throughout the test on a portable laptop computer.

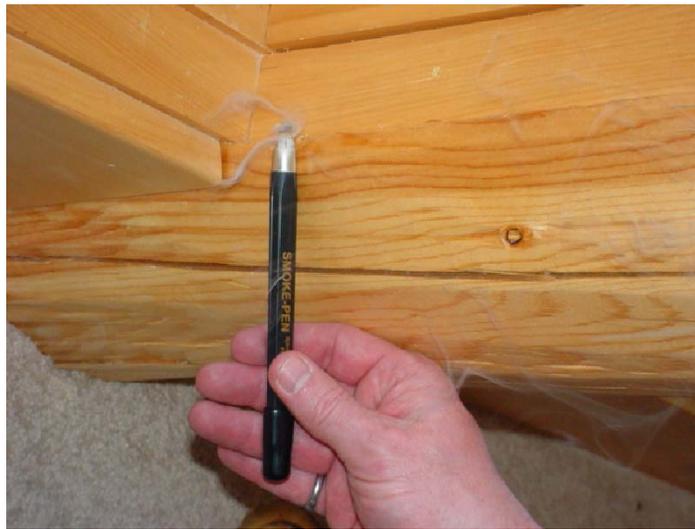
Figure 2. Smoke pen utilization for air infiltration identification during blower door testing.

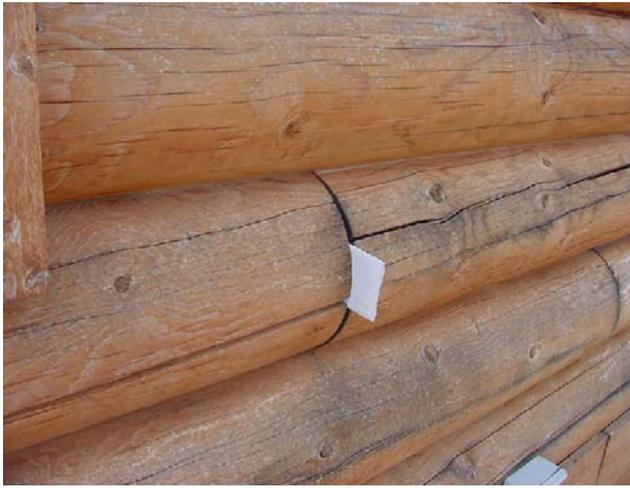
Figure 3. Open / un-sealed butt joint between logs.

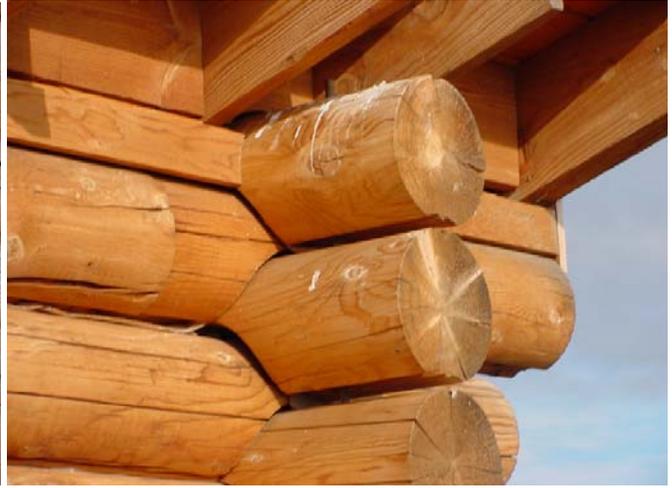
Figure 4. Open / un-sealed corner and successive joinery between logs.

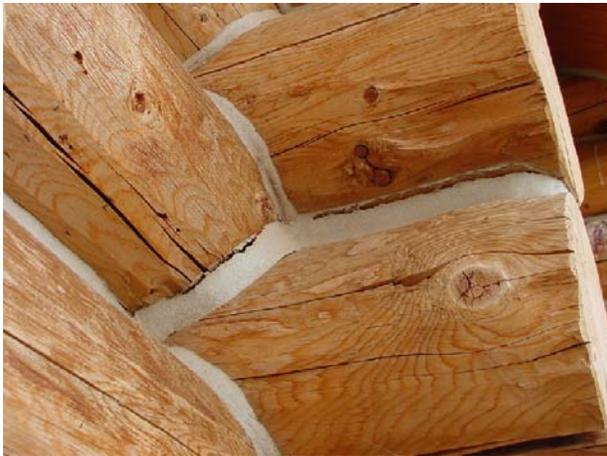
Figure 5. - Adhesively failed chinking at wood-to-wood log joinery.
