**Testing of Lateral Resistance of  
Handcrafted Log Walls Phase I and II**

Prepared for  
International Log Builders' Association

March, 2002

Project No. 3512 / 3512A

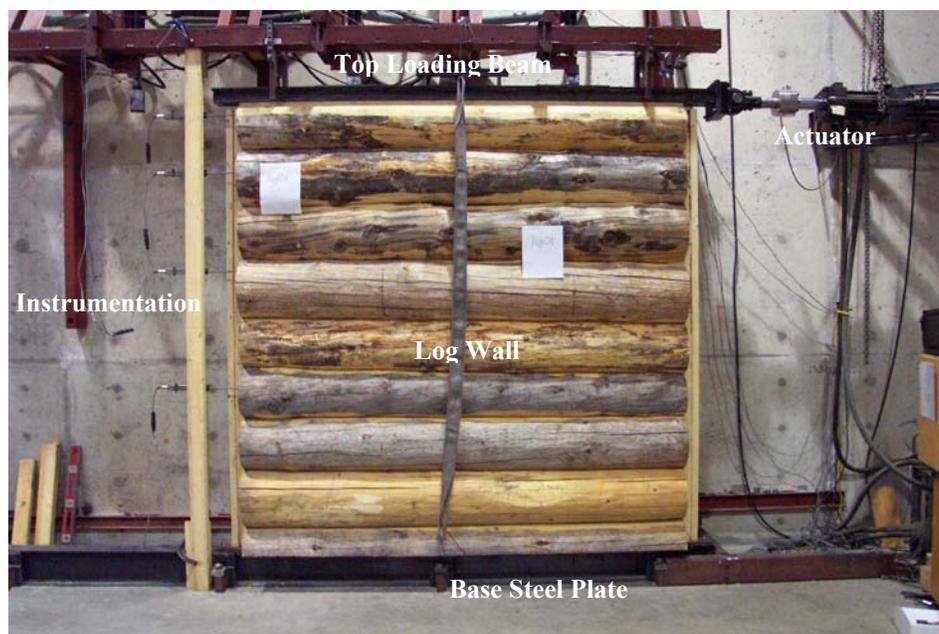
**Figure 1 The lateral load testing apparatus with log wall specimen ready for testing**

All log walls tested were 2.44 m (8 feet) by 2.44 m (8 feet) in size. Each wall consisted of nine logs, with diameters varying from 305 to 355 mm (12 to 14 inches). All logs were grooved along the length and notched for corners, where applicable. The logs were also marked for the order and orientation of their placement in the walls. The bottom log (log 1) was trimmed to match the testing apparatus bottom steel plate and was bolted using ten 12.7 mm (1/2 inch) bolts to the plate to provide fixture against lateral loads. The logs were then placed one by one on the top of each other, including the wood pins and corner logs where applicable, according to the marking scheme provided by the client. The top log (log 9) was trimmed to a 100 mm (4 inch) wide top to accommodate the top loading beam (horizontal spreader bar) be bolted with four 12.7 mm (1/2 inch) bolts to the top log. The top loading beam can have up to 111 kN (25,000 lbs) of lateral load applied through an actuator that is pin-connected to the right end side of the top loading beam. In addition it can also have up to 1.7 kN/m (1,200 lbs/ft) vertical load applied through several actuators with rollers at the point of loading. The test setup with a log wall ready for the test one is shown in Figure 1.

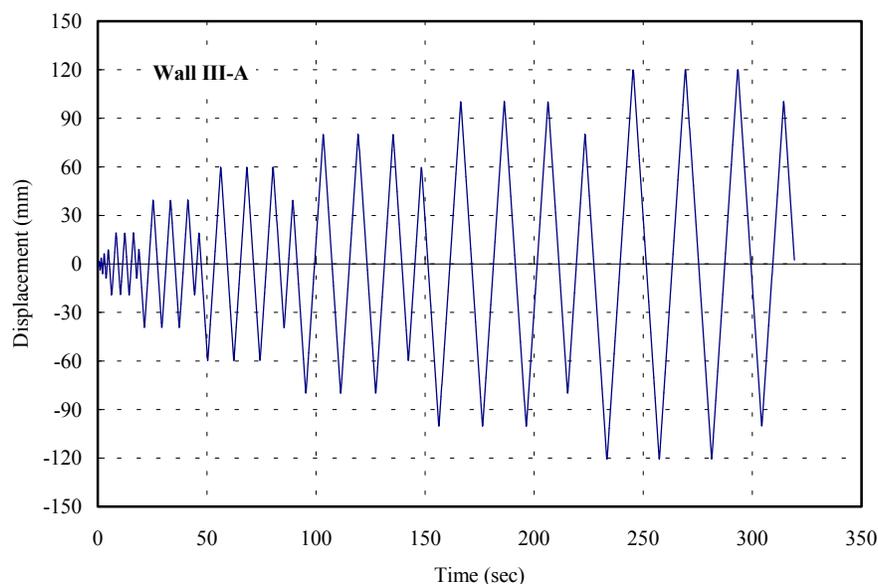
**Figure 2 Cyclic testing protocol ISO-2001 used in the testing program**

For the quasi-static pushover tests, a constant rate of loading (displacement) was used at 7.6 mm (0.3 inches) per minute. Cyclic tests were conducted using the International Organization for Standardization cyclic testing protocol, ISO-2001 (ISO/DIS 16670 2001). All tests were conducted with a total vertical load of 5.34 kN (1,200 lbs) except for the tests 3 which was conducted with a vertical load of 10.68 kN (2,400 lbs), and tests 6 and 10 with a vertical load of 44.48 kN (10,000 lbs). The cyclic testing protocol used is shown in Figure 2.

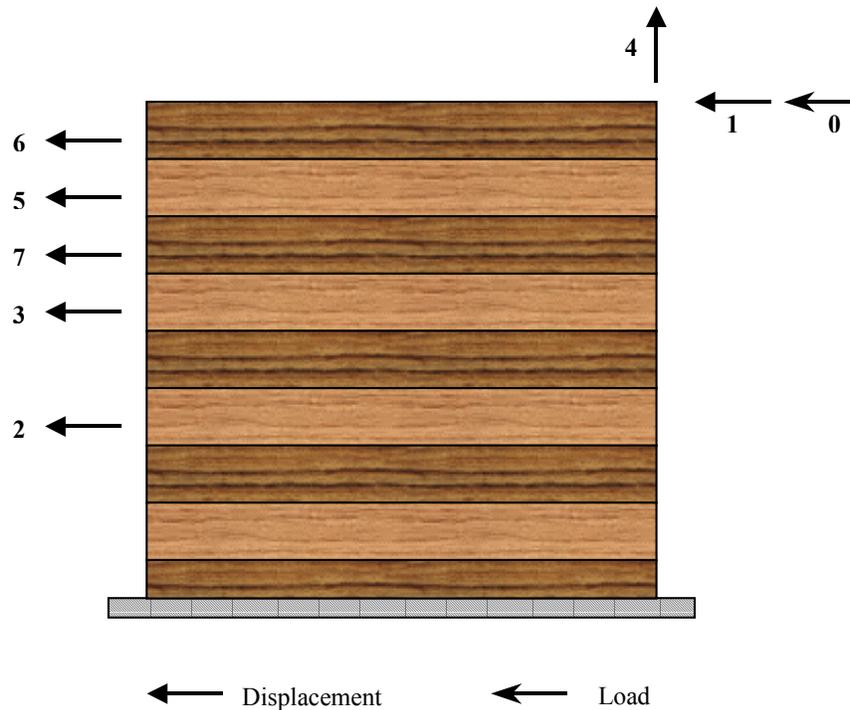
**Figure 3 Location of the instrumentation points on the log wall**

mm (2.25 inches), if reversible displacements were expected. The list of all instrumentation channels is given in Table 2, while their location and channel numbering is shown in Figure 3.

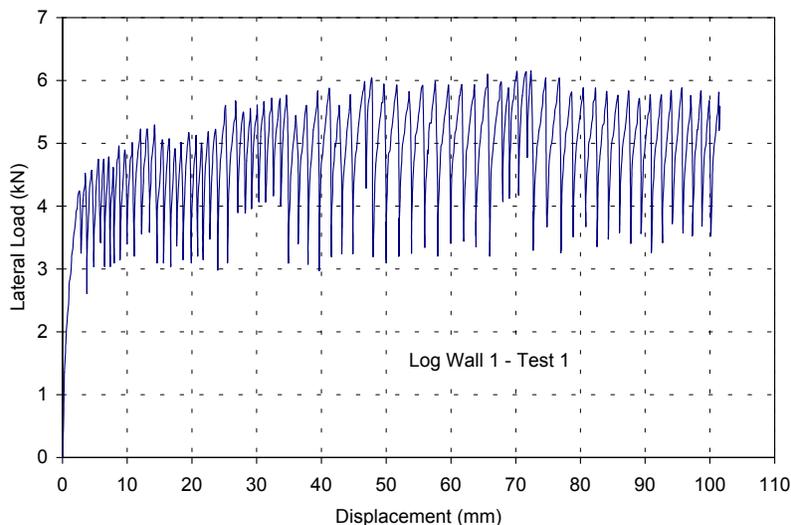
**Figure 4 Load-deformation relationship at the top log level of Wall 1 - test 1**

As shown in Figure 4, the load-deformation relationship of the wall is characterized by two mechanisms, friction, and wood crushing, with friction being the basic component of load transfer. After lateral load at any certain point has exceeded the friction capacity, a slip along one of the surfaces between logs occurred, resulting in sudden drop in the lateral load resistance. This was followed by rise in lateral load resistance when friction between logs increases due to wedging effect and wood crushing along the grooves between logs. This pattern was constantly observed during the test. However, as shown in Figure 4, the wall was able to sustain a deformation of over 100 mm (4 inches), and almost reaching the transducers' capacity, without showing significant reduction in strength properties. This kind of deformability is a very desirable feature for a wall component when subjected to earthquake ground motion.

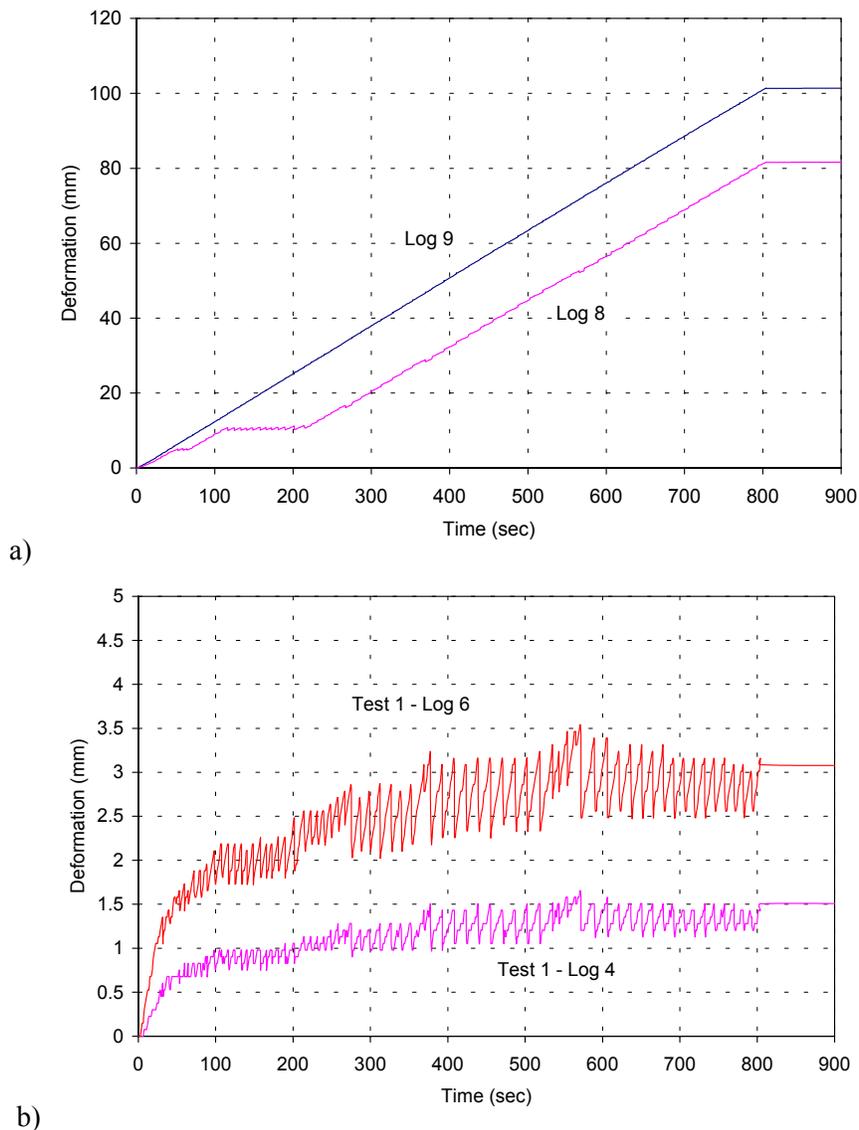
**Figure 5 Displacement histories of logs obtained during test 1: (a) top log and log 8 (b) log 6 and log 4**

Another examination of the load transfer mechanism can be made using the displacement histories of different logs presented in Figure 5. During the initial phase of the test, the lateral force applied to the top log was transferred evenly through friction and wood crushing to the log 8 below. Using the same mechanism, the force is transferred down to the bottom log. During this early phase, the displacement of

the log 8 closely resembles that of log 9 (Figure 5a). At approximately 40 seconds into the test, slipping occurred between the two logs, as the applied lateral force grew larger than the friction between them. However, at a later instance in the test (at approximately 60 seconds) as a result of increased friction between the logs (wood crushing along the groove), the force got transferred down to the log 8 again. Both patterns had occurred once again, approximately at 110 and 210 seconds into the test (Figure 5a). After this time, the rate of displacement increase of log 8 closely resembles that of the top log, suggesting that the slip mechanism has shifted down below the log 8. Having the displacement histories of log 4 and 6 in mind (Figure 5b) one can conclude that the major slip has occurred below log 8, but above log 6.

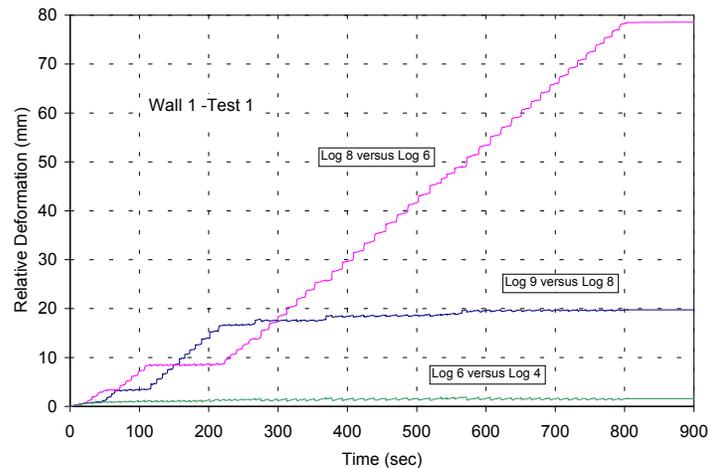
**Figure 6** Relative displacement histories of logs during test 1

The same observation can be made by analysing the relative displacements of the logs in the wall during the test (Figure 6). As the figure shows, the largest relative deformation occurred somewhere between

logs six and eight. By visual inspection of the deformed shape of the wall after the test, we can confirm that maximum relative slip occurred between the log six and seven. The deformed shape of the wall after the test is shown in Figure 7a, while the close-up view of the left side of the wall where the maximum displacement occurred is shown in Figure 7b.

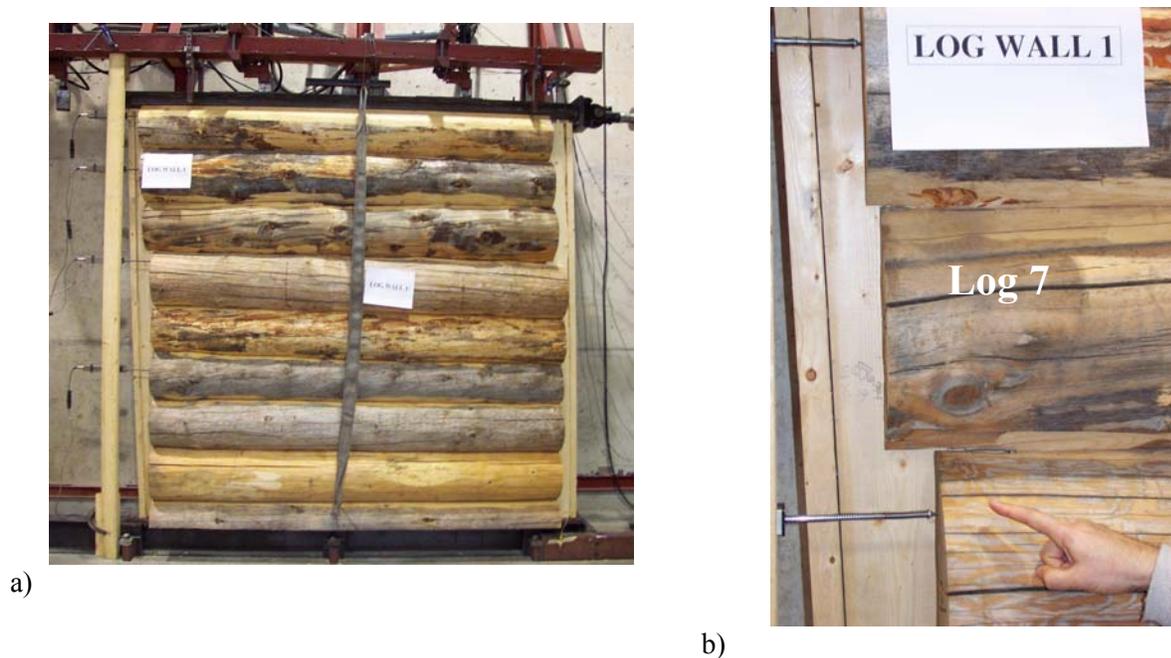
**Figure 7** Deformed shape of the wall after the test 1: (a) front view; (b) Close-up view of the left side

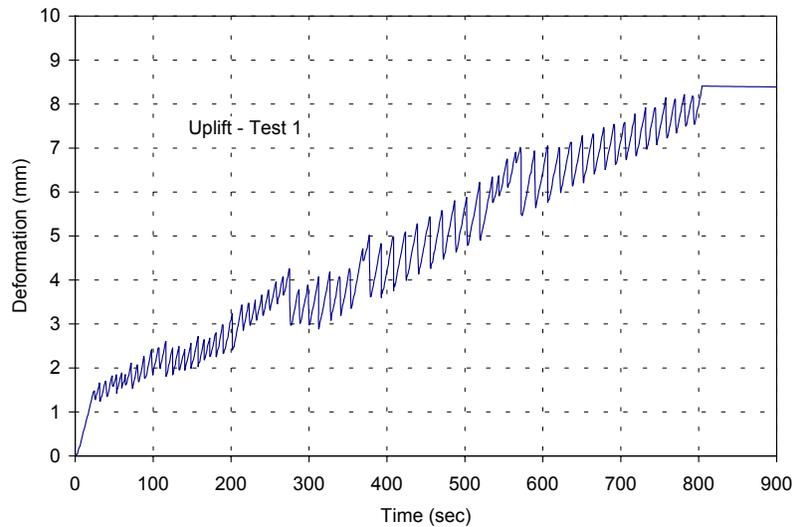
**Figure 8 Time history of the vertical uplift at the top right corner of the wall during test 1**

at  $0.4 P_{max}$ , where the  $P_{max}$  is the maximum load obtained from each test (CEN 1995). The coefficient of friction for the wall calculated as the ratio of the maximum lateral resistance versus the applied vertical load was found to be 1.149. If we take into account that the main slip occurred between logs 6 and 7, and add the weight of the top three logs into the equation (approx. 570 lbs), the friction coefficient stands at approximately 1.28. Finally, during the test the wall exhibited uplift on the side where the lateral load was applied. The maximum uplift value recorded at the end of the test was 8.5 mm (0.335 inches). The time history of the uplift recorded during the first test is shown in Figure 8.

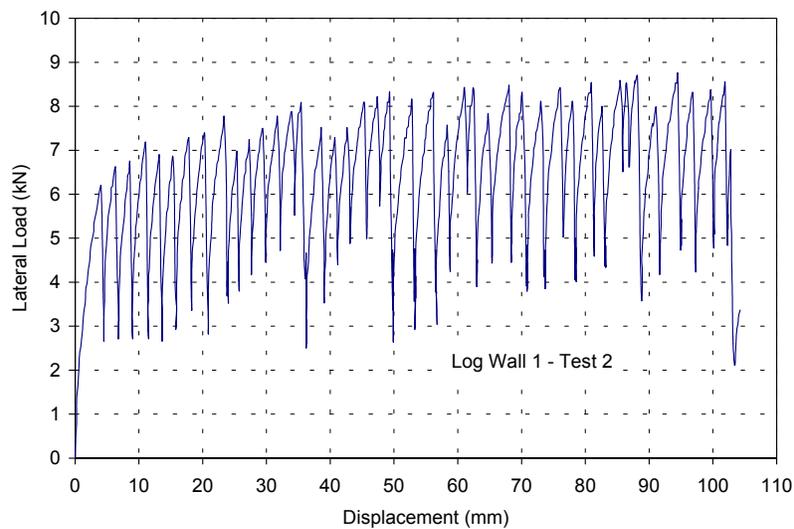
**Figure 9 Load-deformation relationship at the top log of Wall 1 - Test 2**

As shown in Figure 9, the wall exhibited similar behaviour to that during the first test. The load pulses, however, were now less frequent but larger in magnitude. This is a direct result of the fact that the friction surfaces (grooves) between the logs were smoothed during the first test. During the test 2, the wall was able to sustain a maximum lateral load of 8.741 kN (1,965 lbs), which is 40 % higher than the load in test 1. The higher vertical load also made the displacement distribution more proportional (following a triangular deformation shape) along the height of the wall. Displacement histories recorded at different logs during test 2 are shown in Figure 10, while a photo of the deformed shape of the wall at the end of the test is shown in Figure 11.

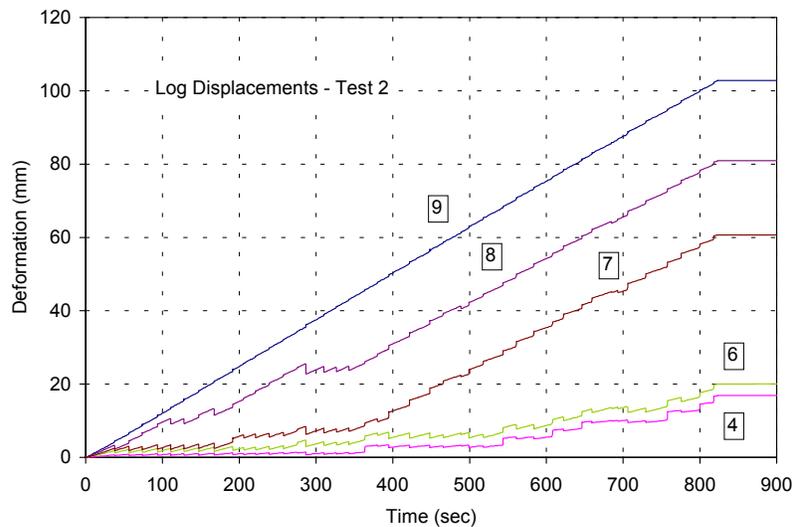
Figure 10 Displacement histories recorded at different logs during the test 2

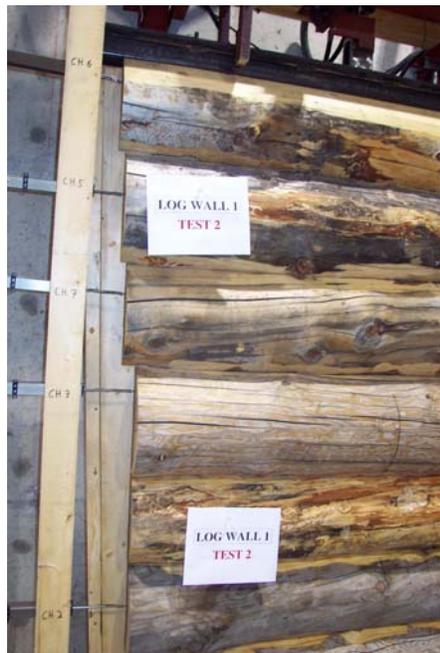
Figure 11 Deformed shape of the wall at the end of the second test

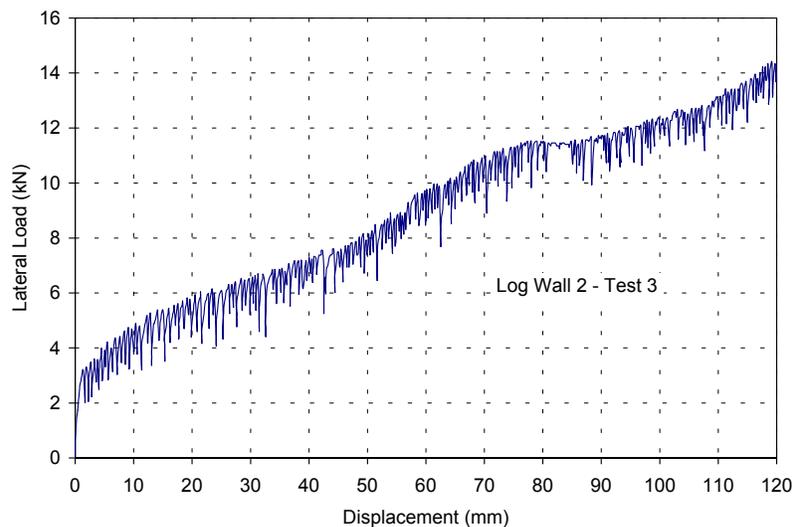
**Figure 12** Load-displacement relationship at the top log level of the wall with hardwood pins

The load-displacement relationship of the wall at the top log level is shown in Figure 12. The wall behaviour has changed significantly when compared to the behaviour of walls without pins. The wall resistance is again a combination of friction and wood crushing, but in this case the wood crushing is the far more prevalent component. The pins are the primary wall components that transfer the load down to the foundation. As the lateral load increases during the test, the hardwood pins start crushing the softer wood of the logs around the holes in the direction of the load. A crushed hole with the pin in it at the end of the test is shown in Figure 13.

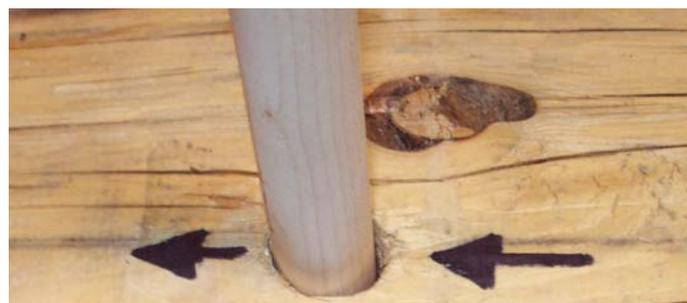
**Figure 13** Wood crushing mechanism around a hole of a pin at the end of test 3

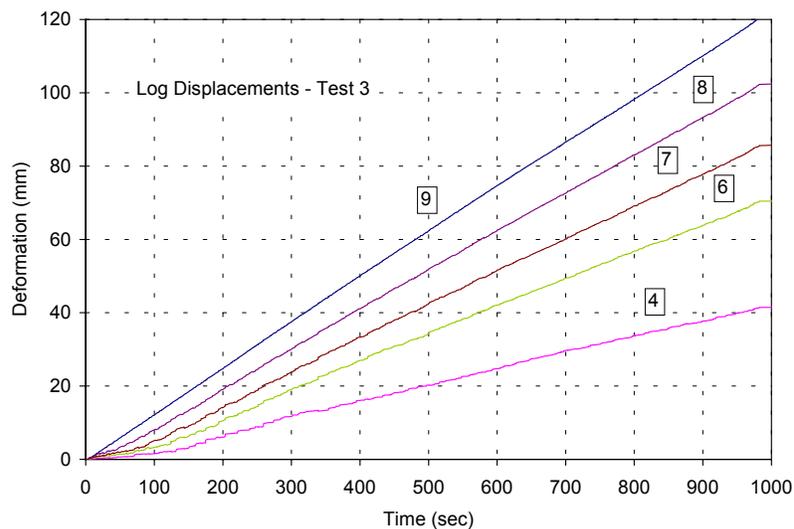
**Figure 14 Displacement histories recorded at different logs during the test 3**

The wall during test 3 was able to sustain a deformation of over 120 mm (4.8 inches), almost exceeding the transducer's capacity, without showing reduction in strength properties. Hardwood pins proved to be an excellent load transfer component, which resulted in very proportional displacement distribution of logs along the height of the wall. Displacement histories recorded at different logs during this test are shown in Figure 14.

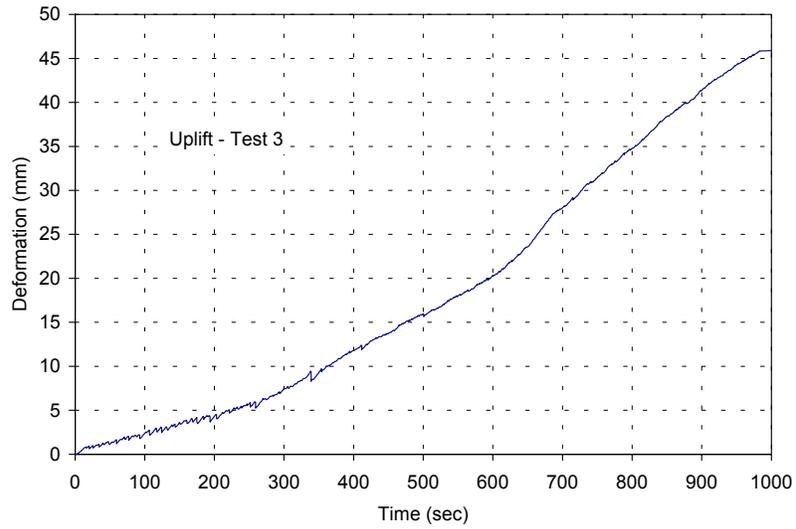
**Figure 15** Time history of the vertical uplift at the top right corner of the wall during test 3

While the maximum uplift of the walls during the first two tests were in the neighbourhood of 9 mm (0.35 inches), the maximum uplift of the wall with pins was 45.9 mm (1.8 inches). This uplift, which is more than five times larger than the uplift measured in previous tests, caused formation of the gap between several logs on the right side of the wall. Time history of the uplift observed during the test 3 is shown in Figure 15. A photo of the deformed shape of the wall at the end of the test is shown in Figure 16a, while the gap formed between logs due to uplift is shown in Figure 16b.

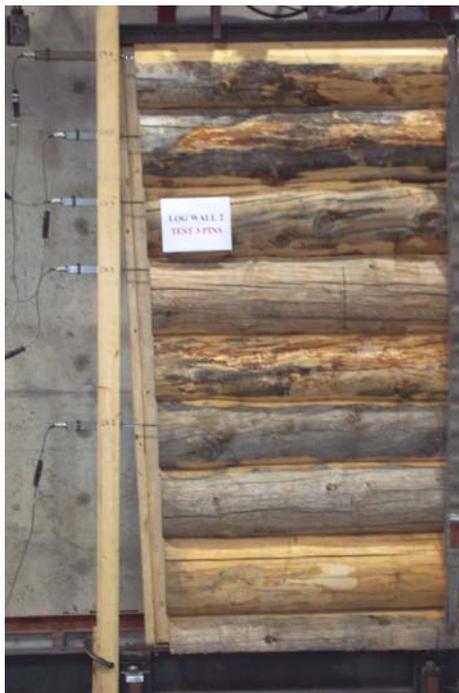
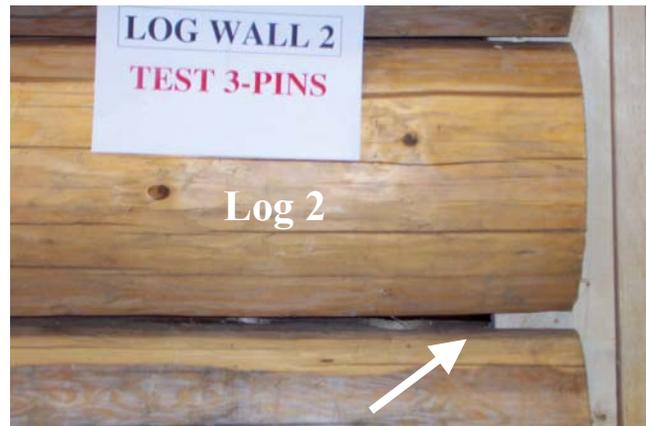
**Figure 16** Photos of the wall at the end of test 3 (a) Deformed shape; (b) Gap between logs due to uplift

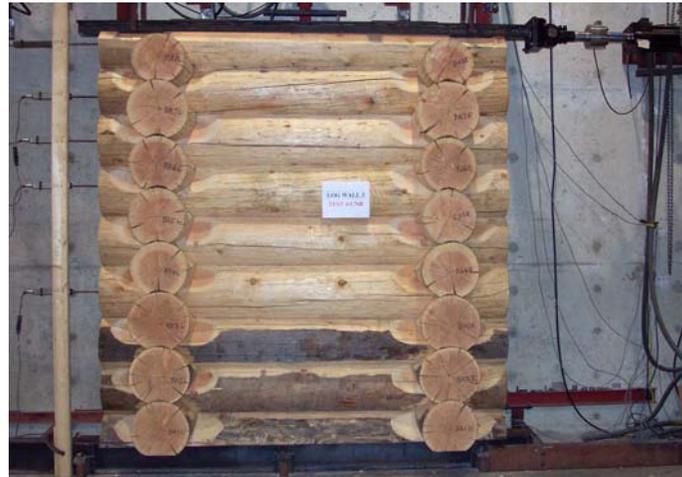
**Figure 17 Handcrafted log wall with corners - setup for the test 4**

The fourth and last test from the pushover part of the testing program was to determine the lateral load resistance properties of handcrafted log walls with corners. The wall was built according to the instructions from the client who supplied the logs. A photos of the wall with corners placed in the testing apparatus is shown in Figure 17.

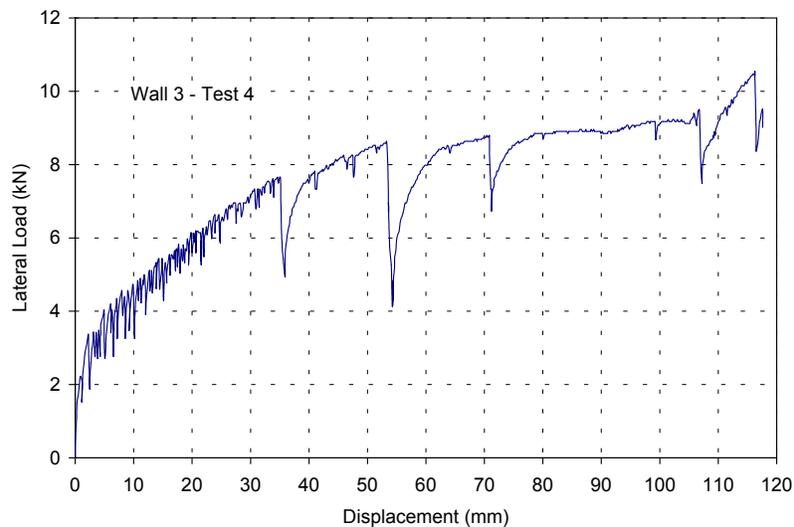
**Figure 18 Load-displacement relationship at the top log level of the wall with corners- test 4**

The load-displacement relationship of the wall at the top log level is shown in Figure 18. The wall behaviour was again found to be different than in any other configuration previously tested. The wall resistance is combination of friction between the wall logs and wood crushing between the wall and the corner logs. The corner logs were able to transfer the load down to the foundation in more efficient way than the wall with no corners (test 1). As the lateral load increased during the test, the crushing between logs and corner logs intensified. However, at certain point of time when the lateral load build-up was

larger than the friction resistance between certain components of the wall at that time, a slipping occurred. Four large events of slipping were recorded during the test. These episodes are visible as significant load reduction peaks in Figure 18.

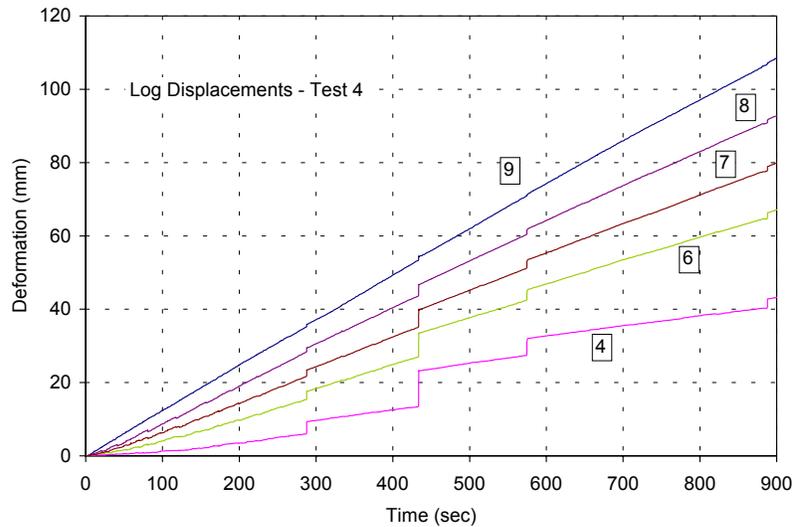
Figure 19 Displacement histories recorded at different logs during the test 4

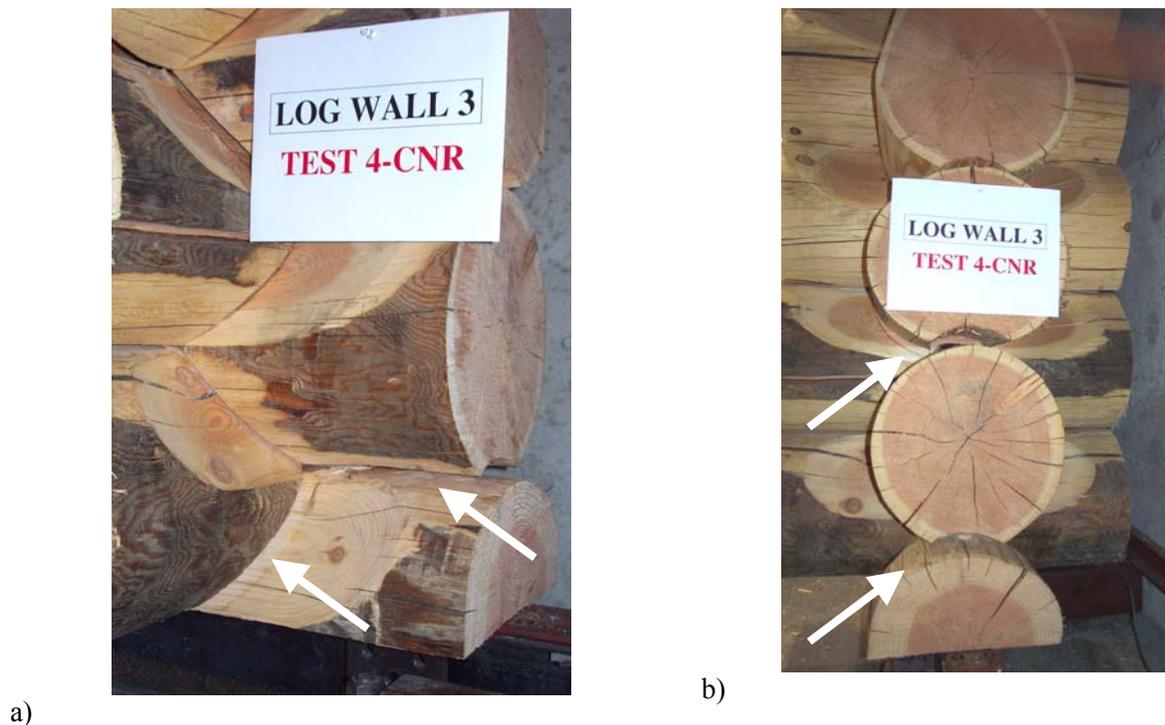
Figure 20 (a) and (b) Gap formation in log wall with corners due to uplift exhibited during the test 4

The maximum uplift measured during this test was 49.4 mm (1.9 inches). This uplift was the highest recorded for any configuration tested so far and caused lifting of several logs from the wall and the corners on the right side of the wall. Photos of the gap formed between logs due to uplift are shown in Figure 20 (a) and (b). As mentioned before, a summary of the strength and stiffness characteristics of the four walls tested during the pushover part of the program are presented in Table 3. Stiffness of the walls during tests 3 and 4 was not calculated as required by the CEN Standard, because that would result in non-realistic values.

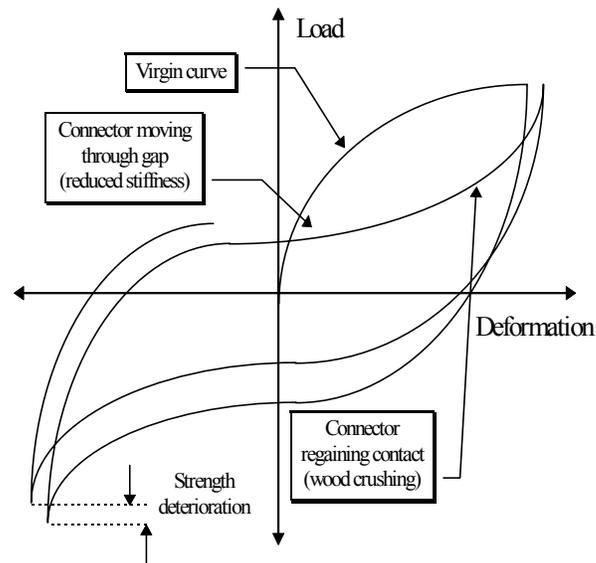
**Figure 21 Typical hysteretic behavior of a timber structure component.**

In the second phase of the experimental program six cyclic (reverse load) tests were conducted to examine the seismic behaviour of different configurations of handcrafted log walls. During cyclic tests, a reverse displacement pattern with increasing amplitudes is introduced at the top of the wall. This pattern is supposed to resemble the reversing displacements present in a real earthquake but at much lower velocity. The configuration of log walls tested under a cyclic protocol (tests 5 to 10) is given in Table 1. The main result that can be obtained from a typical cyclic test is the hysteretic load-deformation curves of the tested element. In timber structures, components or connections, the hysteresis curves are mildly to severely pinched. A typical hysteresis curve obtained from cyclic tests on a timber connection is shown in Figure 21.

The pinching effect results in thinner hysteresis loops in the middle of the loop than near the ends. In wood connections this phenomenon is caused by the loss of stiffness at small joint slips, where a cavity

around the fastener is formed by crushing of the wood. The fastener shank, without wood support within the deformation level of the slip, provides the sole resistance to the applied load. The stiffness of the connection again increases gradually as the fastener makes contacts with the surrounding wood at higher deformations.

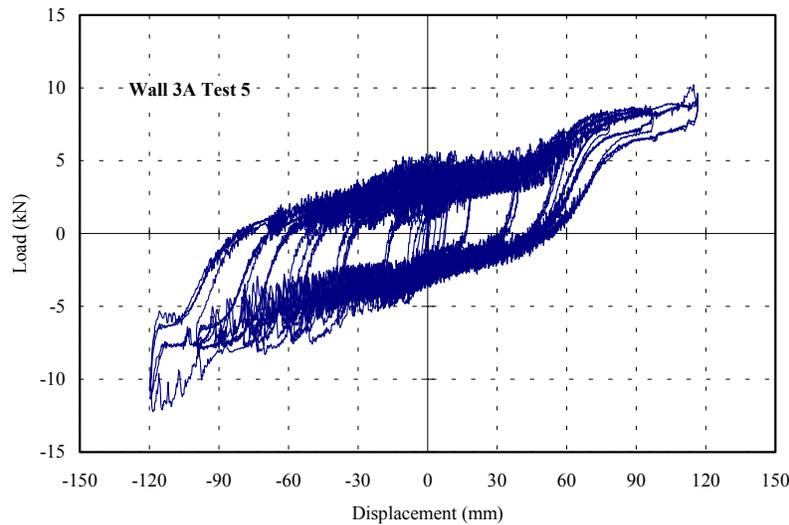
**Figure 22** Load displacement hysteresis loop for wall with corners obtained during test 5

In tests 5 and 6 the seismic resistance of log walls with corners was investigated. For both tests the same wall configuration from test 4 was used, so it should be noted that the results do not represent a wall with its initial strength and stiffness properties. The hysteresis load-displacement curve at the level of the top log obtained from test 5 is shown in Figure 22. As shown in Figure 22, the response is again a combination of wood crushing and friction components. This combination of resistance mechanisms produced a hysteresis curve that is different from the typical ones obtained for conventional timber structures. The curve shows a certain level of stiffness degradation, but shows no strength degradation. In addition, the hysteresis loops are thicker in the middle than near the ends, which is exactly the opposite of the behaviour obtained from conventional wood components. This phenomenon is believed to be largely due to constant changes of the amount of friction and wood crushing components in the total lateral resistance of the wall at any particular time, and any lateral deformation level. The wall was able to sustain a maximum lateral load of 12.22 kN (2,747 lbs). During the test a significant uplift of the wall was observed, with the maximum value of 58.1 mm (2.29 inches) at the end of the test. The uplift caused lifting of several logs from the wall and the corners on the right side of the wall. Significant amount of uplift is not desirable in seismic response of timber structures. The time history of the uplift measured at the top right corner during the test is shown in Figure 23.

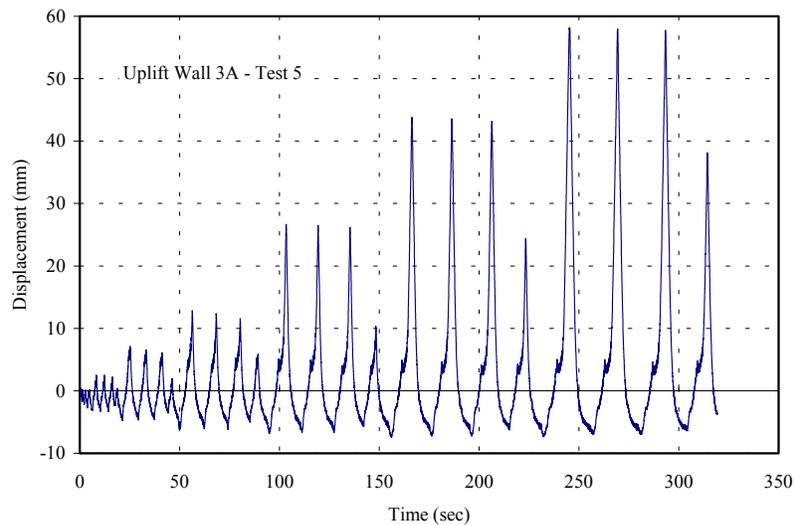
**Figure 23** Time history of the uplift during test 5

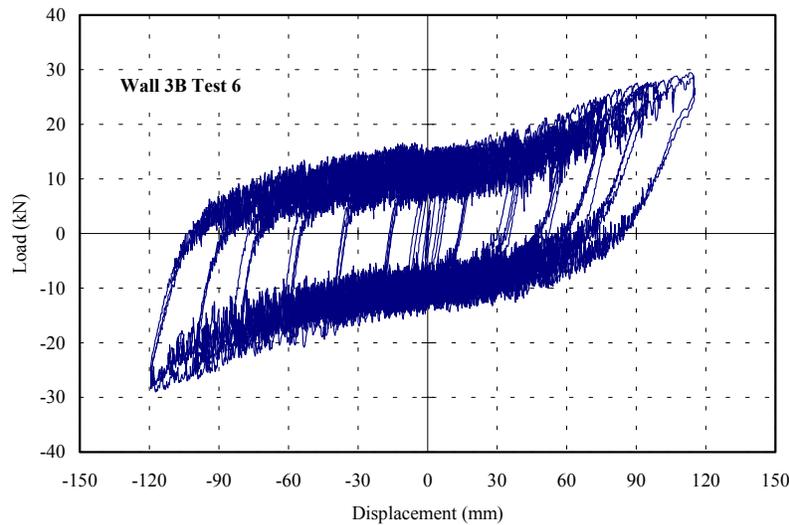
**Figure 24** Load displacement hysteresis loop for wall with corners obtained during test 6

To study the effect of vertical load on the load-deformation response of a wall with corners, a vertical load of 44.48 kN (10,000 lbs) was applied to the same wall during the test 6. The increased vertical load enabled the wall to carry a maximum horizontal force of 29.4 kN (6,604 lbs). The hysteresis loop obtained during test 6 (Figure 24) has an increased and almost uniform thickness, with much more energy dissipated (larger area inside the loop) than the curve in test 5. The increased vertical load also helped reduce the uplift of the wall. Although the time history of the uplift during the test 6 has the same shape as the one shown in Figure 23, the maximum uplift value was reduced to 26.2 mm (1.03 inches).

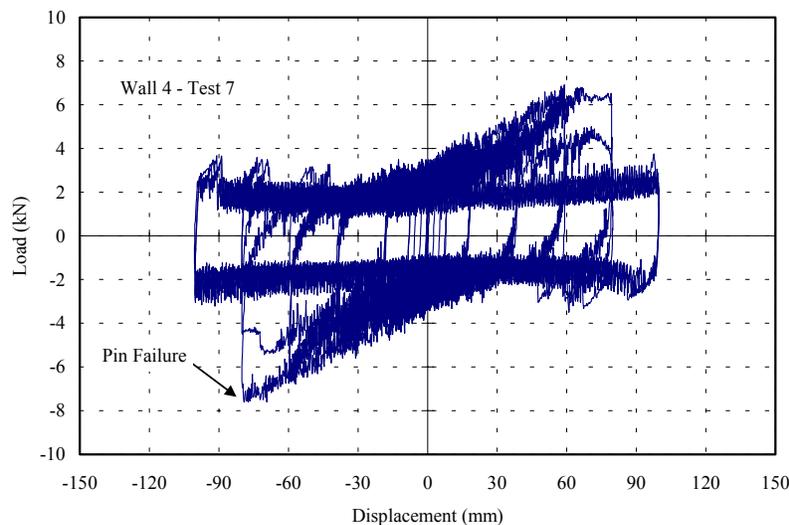
**Figure 25** Load displacement hysteresis loop of wall with softwood pins obtained during test 7

As shown in Figure 25, the wall exhibited relatively thin hysteresis loops with no significant potential for energy dissipation. The wall was able to carry a maximum lateral force of 7.6 kN (1,709 lbs), after which the softwood pins at the top of the wall (between log 8 and 9) broke. The breaking of the pins was abrupt and resulted in sudden drop of the lateral load capacity of the wall. After this, the top log was simply sliding on the top of the other logs with no significant lateral resistance. This type of brittle failure is the

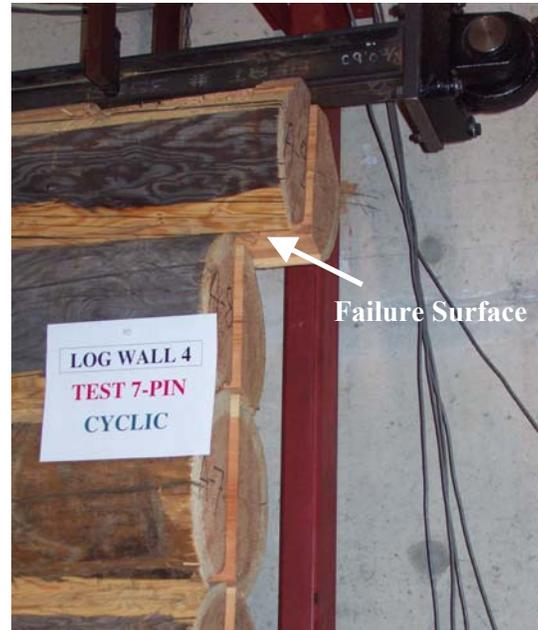
**Figure 26. The failure mechanism of the wall with softwood pins - sliding of the top log**

least desired failure mode in seismic design of structures and should be avoided. A photo of the wall after the pins were broken is shown in Figure 26.

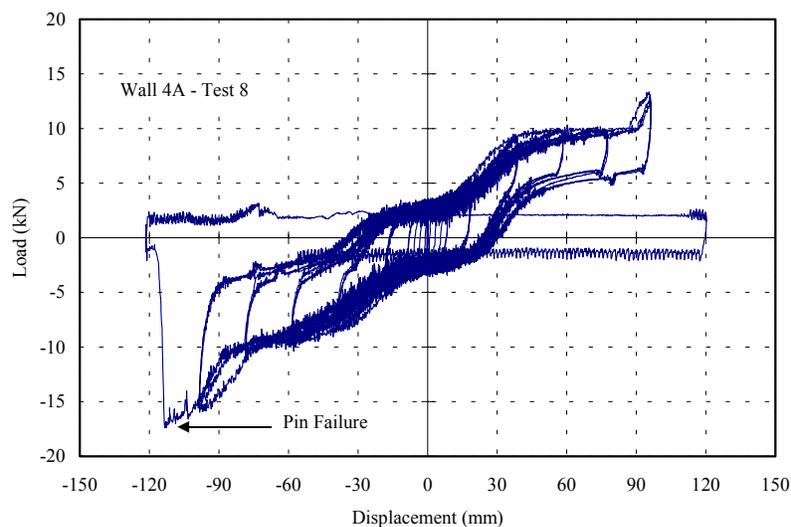
**Figure 27 Load displacement hysteresis loop of wall with hardwood pins - test 8**

The load-displacement hysteresis curve obtained from test 8 is shown in Figure 27. The combination of friction and wood crushing around the hardwood dowels resulted in hysteresis loops with relatively uniform thickness. The load increased until it reached 17.4 kN (3,906 lbs). At that point both hardwood pins at the top of the wall (between log 8 and 9) broke. Pin failure was abrupt and again resulted in sudden drop of the lateral load capacity of the wall (Figure 27). After the pin failure the wall has lost almost all of its lateral resistance and the top log simply kept sliding on the top of the other logs. Although the log wall with hardwood pins was able to carry 128% more load than the same wall with softwood pins, they experienced the same brittle failure modes. This type of abrupt failure mode is not desired in seismic design of timber structures and should be avoided. A photo of one of the broken pins between logs 8 and 9 is shown in Figure 28.

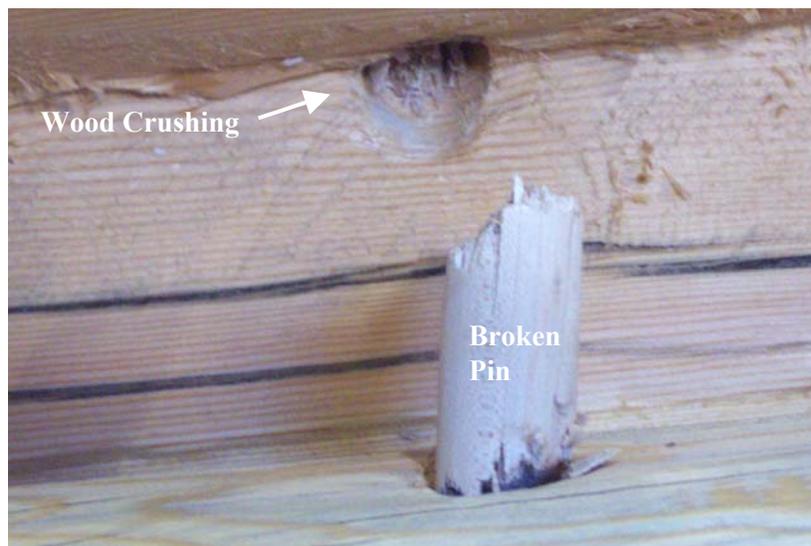
**Figure 28 Close-up view of the broken pin between logs 8 and 9 during test 8**

As shown in Figure 28, the hardwood pins caused extensive wood crushing around the holes in the softwood logs before they broke. Wood crushing is desirable ductile mechanism of energy dissipation in the seismic design of timber structures. During the test, the wall with hardwood pins exhibited an uplift pattern similar to the walls previously tested. The maximum uplift value at failure was 52.9 mm (2.08 inches).

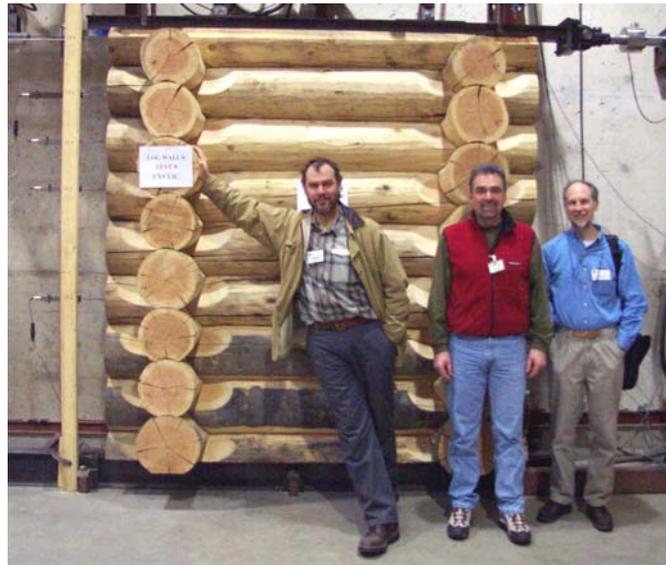
**Figure 29** ILBA members with the log wall specimen placed in the testing apparatus for test 9

In tests 9 and 10 the lateral resistance of log walls with hardwood pins and corners was investigated. A vertical load of 5.34 kN (1,200 lbs) was used in test 9, while the same wall was subjected to a vertical load of 44.48 kN (10,000 lbs) during the test 10. Three members of the International Log Builders' Association, Mr. Tom Hahney, Mr. Dave Gardner and Mr. John Boys, observed these tests. A photo of the wall specimen prepared for test 9 and guests from the ILBA is shown in the Figure 29.

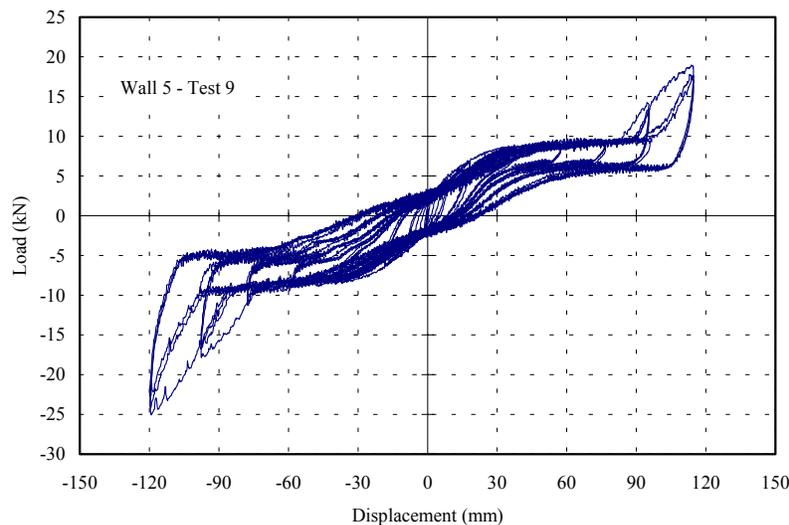
**Figure 30** Load displacement hysteresis loop for wall with hardwood pins and corners - test 9

The load-deformation hysteresis loop obtained from test 9 is shown in Figure 30. The presence of corner logs helped increase the wood crushing component of the resistance. This resulted in a 44% increase of the total lateral load resistance of the wall compared to the wall without corners (test 7), for the same displacement level. The maximum load obtained during the test was 25.03 kN (5,627 lbs). Significant vertical uplift was again noted during the testing with the maximum uplift exhibited during the test being 53.5 mm (2.1 inches).

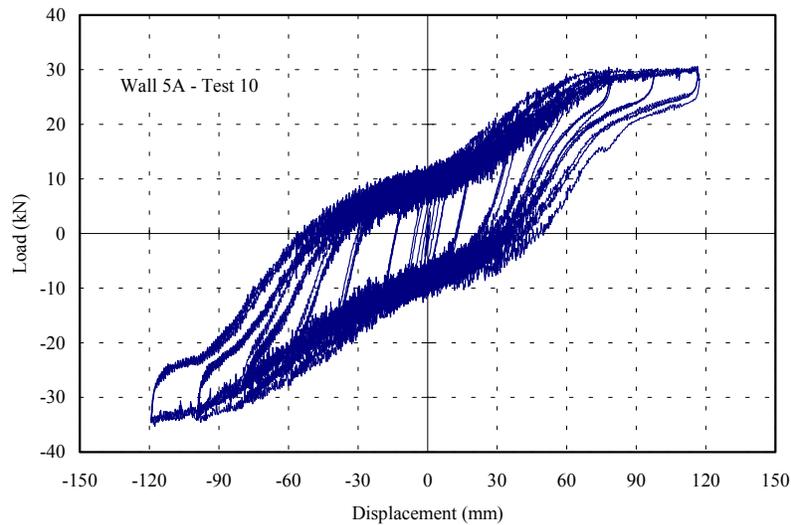
**Figure 31 Load displacement hysteresis loop for wall with hardwood pins and corners - test 10**

By increasing the vertical load to 44.48 kN (10,000 lbs) on the same wall configuration during the test 10, a maximum load of 35.3 kN (7,935 lbs) was reached (Figure 31). The higher level of vertical load resulted in thicker hysteresis loops and higher energy dissipation characteristics of the wall, by increasing both, the friction and wood crushing part of the resistance. The maximum value of the uplift recorded was 54.2 mm (2.13 inches), which is very similar to the value obtained during the test 9. A photo of the gap that was developing between the first and the second log due to uplift forces during test 10 is shown in Figure 32.

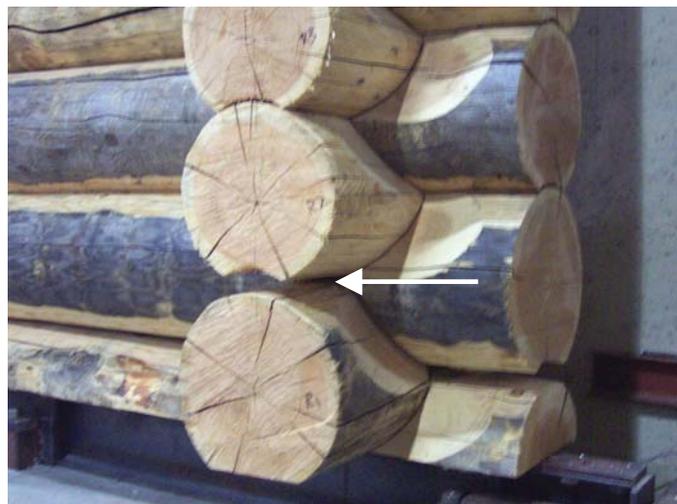
**Figure 32 Gap formation between logs as a result of the uplift forces during test 10**
