United States  
Department of  
Agriculture  
Forest Service  
**Forest  
Products  
Laboratory**  
Research Paper  
FPL 341  
1979

# **Bending Strength of Large Alaskan Sitka Spruce and Western Hemlock Log Bridge Stringers**

By  
R. L. TUOMI, *Engineer*  
R. W. WOLFE, *Technologist*  
R. C. MOODY, *Engineer*  
Forest Products Laboratory,<sup>2</sup>  
and  
F. W. MUCHMORE, *Engineer*  
Alaska Region

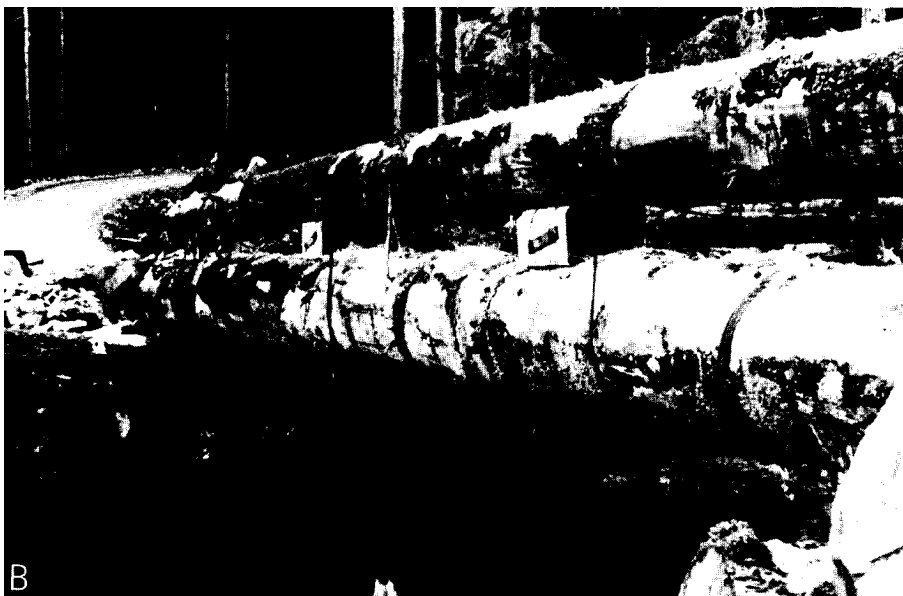
Figure 1.—Log stringer bridges. A—large log stringers are simply placed on log crib abutement. B—bridge with spread brow logs; this bridge spans nearly 100 feet and is designed for 80-ton off highway logging trucks. (M 143 536) (M 143 751-16)

Native log stringer bridges are important and practical structures on both public and private forest lands. They are built from trees cut in the proximity of the bridge site in remote areas where it is not economically feasible or practical to bring in the more conventional construction materials. Several hundred bridges of this type are currently in service in Alaska and Canada, and the more remote areas of the lower 48 States. They carry heavy off-highway logging trucks with loads exceeding 100 tons in spans approaching 100 feet (fig. 1).

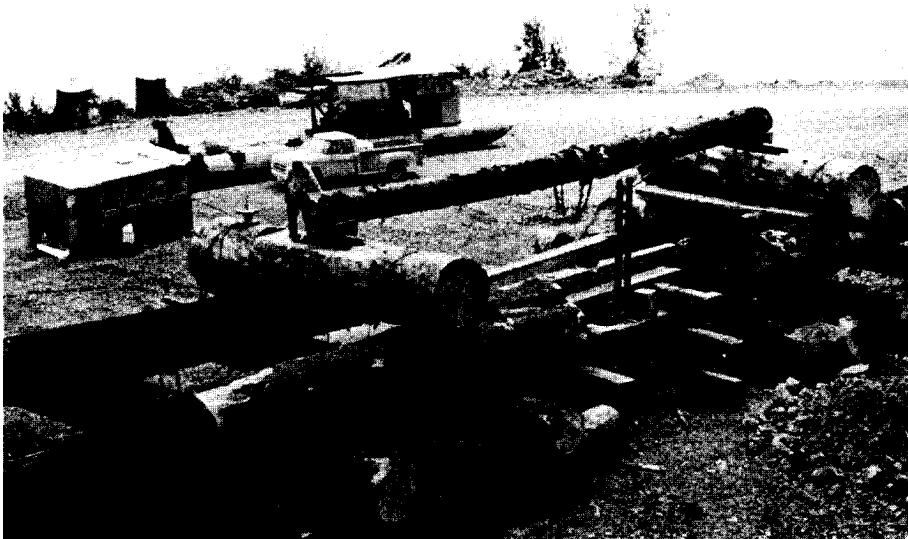
Figure 3.—Overview of the test site. The support cribs were shifted along the base rails for span adjustment. (M 143 750-7)

The site was within a rock quarry that provided a good base, ample space, and easy access from the road.

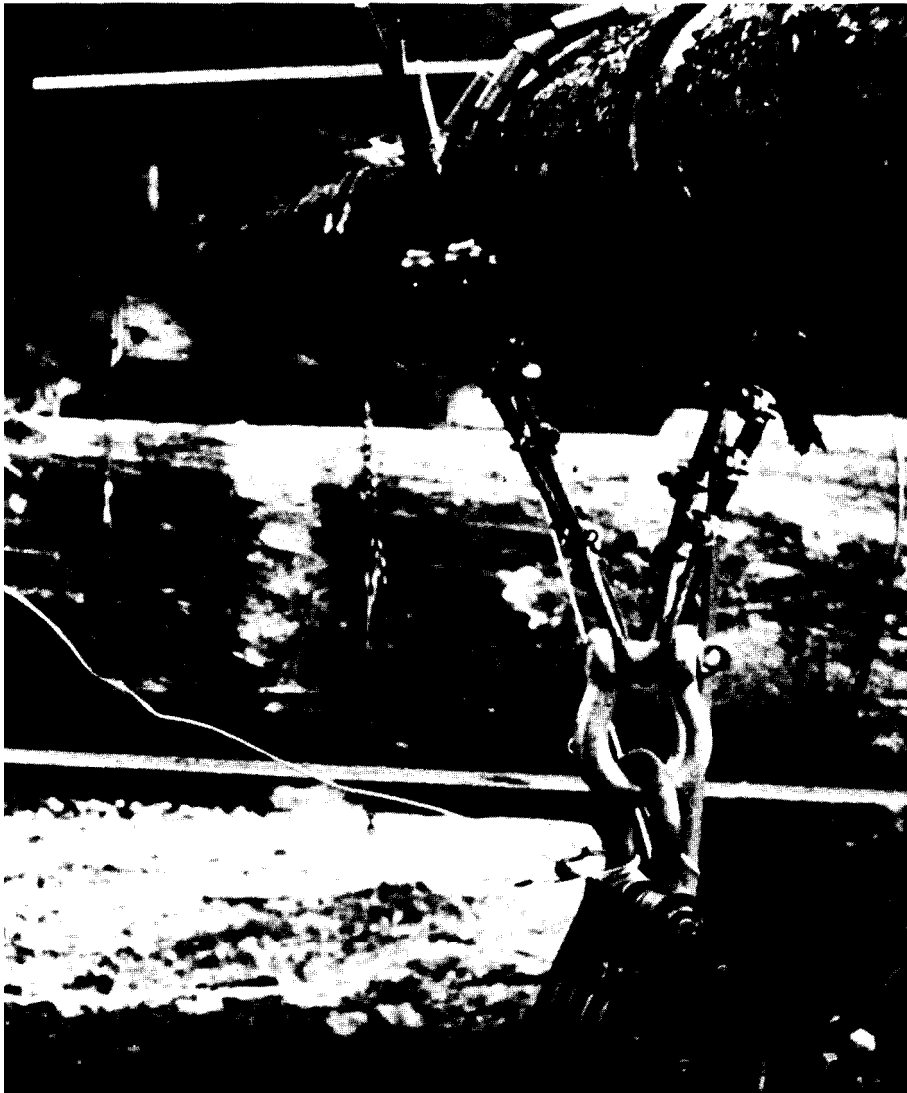
Figure 6.—Girth strap and upper sheave block. The girth strap was designed to reduce compressive stress on the top of the log.  
(M 143 750-16)

The girth strap was needed to distribute the load uniformly to the top surface of the logs to prevent compression failures. It was made up of a number of 6- by 18-inch metal plates. Two round brackets were welded to each plate, and spacer sleeves were installed between adjacent plates. Cables were then threaded through the sleeves and brackets. The sleeves provided a slight gap between plates so that the assembly was flexible enough to match the curved surface of the log. Thimbles and shackles were attached to each end for direct connection to the upper sheave block.

The upper sheave block was next raised using the mast hoist, and was connected to the girth strap with four shackles. The hoist line was slacked off but left connected to the top sheave block to catch it following failure.

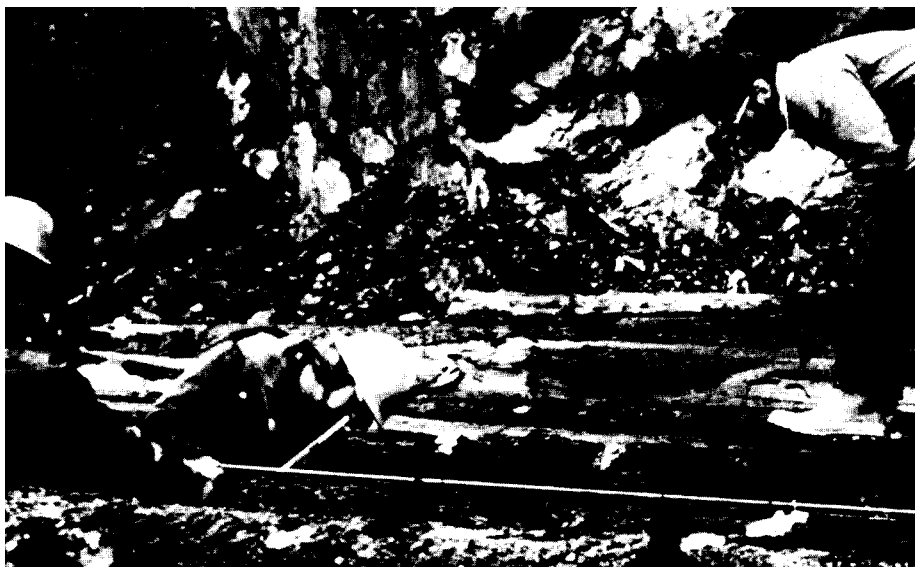
Figure 9.—Mapping defects and obtaining physical measurements on 40 test logs in the sorting area.  
(M 143 750-8)

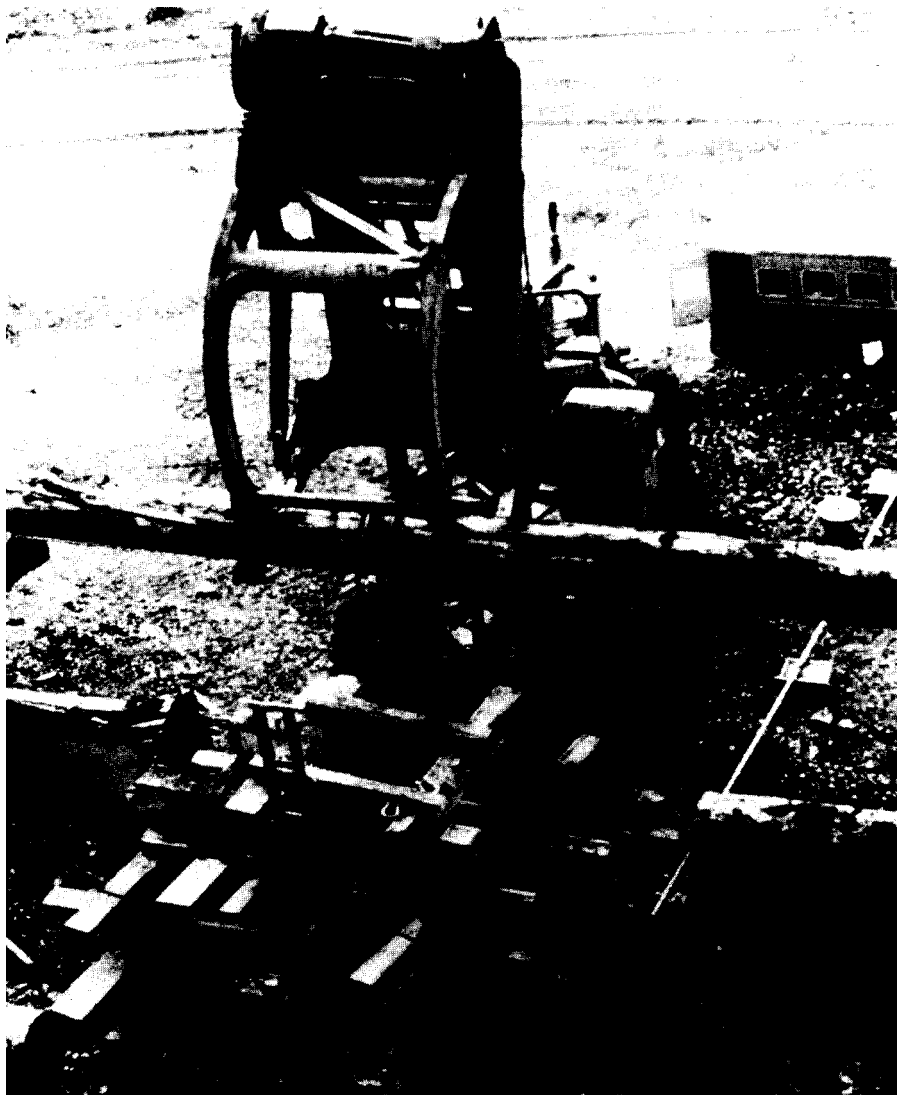
*Figure 10.—Giant log stacker placing test log up on supports. Logs had to be lifted approximately 20 feet.  
(M 143 750-13)*

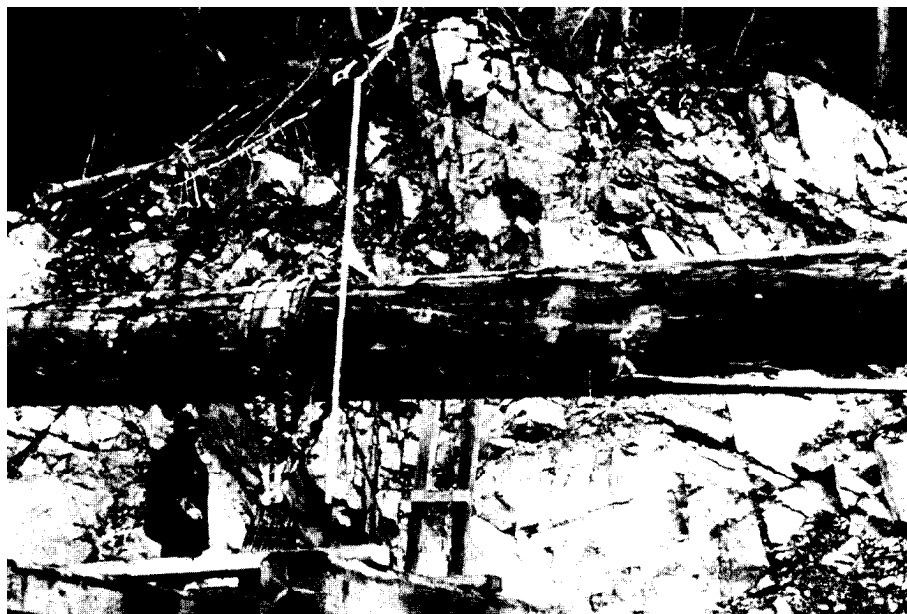
Figure 12.—Sitka spruce logs failed gradually and usually stayed up on supports.  
(M 143 750-10)

The normal failures were quite gradual, starting from shallow and elongated cracks on the tension side. Logs exhibiting normal failures usually stayed up on the supports and retained a certain amount of residual strength (fig. 12). The abrupt type failed suddenly, often falling off the supports (fig. 13).

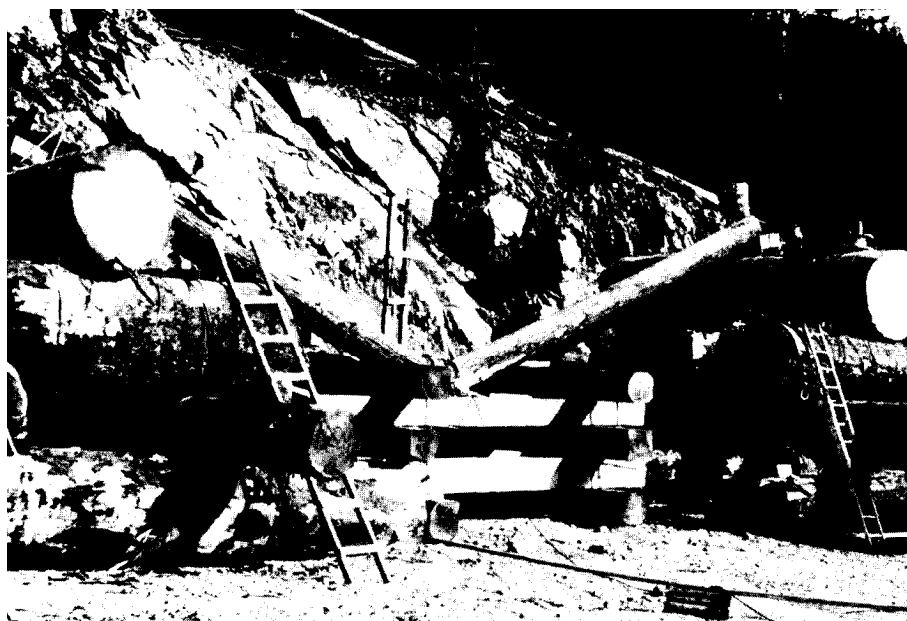
Figure 13.—Western hemlock logs, although slightly stronger than spruce, failed abruptly, often falling to the ground.  
(M 143 750-5)

The western hemlock logs, although slightly stronger than Sitka spruce, failed more often in the abrupt mode. The failure zone had a brash appearance. Seven of the 15 failed abruptly, with five breaking completely and falling from the supports. Only five of the 25 Sitka spruce failed abruptly and only one fell from the supports.
