Reprint Edition

Fire Resistance of Log Walls

By Dalibor Houdek, Ph.D.

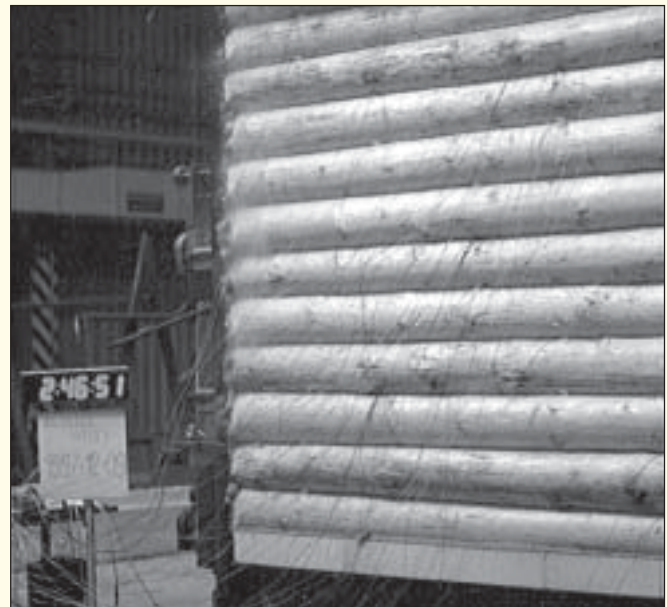
Houdek's experimental log wall. Note the many thermocouple wires to record temperatures inside the wall and on its surface.

The log wall was exposed to fire, and temperatures inside the logs, inside the grooves, and on the unexposed side were continuously monitored and recorded (*photo on page 1*).

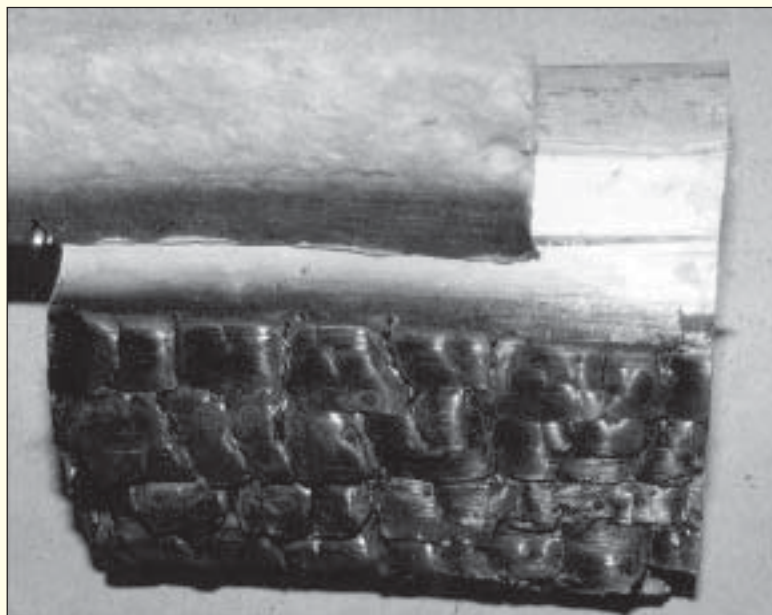
Charred log after the test, with mineral wool batt. No flames penetrated the grooves.

continued to burn for the duration of the test. Large deep cracks developed around the 11th minute. From about the 30th minute the wall surface was red and charred with large deep cracks for the rest of the test. It was observed that when the fire-exposed edge of the lateral groove burned off, the mineral insulation inside the long groove protruded, and expanded to about its initial thickness of 50 mm.

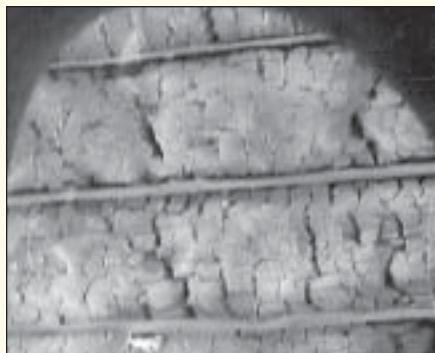
Glowing logs, separated by mineral wool, at 2000°F in the furnace.

The temperature on the hot side of the scribe-fit log wall exceeded 1100°C (2000°F), but the cool side never got above 48°C (118°F), even after almost 3 hours of burning.

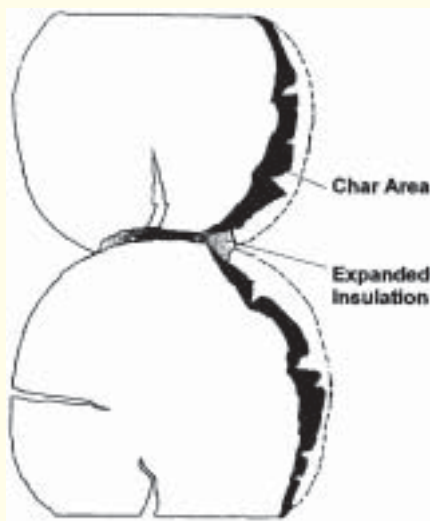
Cross section of log wall after fire test. The mineral wool insulation in the long groove expanded, once the edge of the groove burned off. The insulation created a protective shield against heat penetration through the wall joint.
